General Summary

Structure Tech Home Inspections

Inspection Address
12345 Any Street
Minneapolis MN

Inspection Report

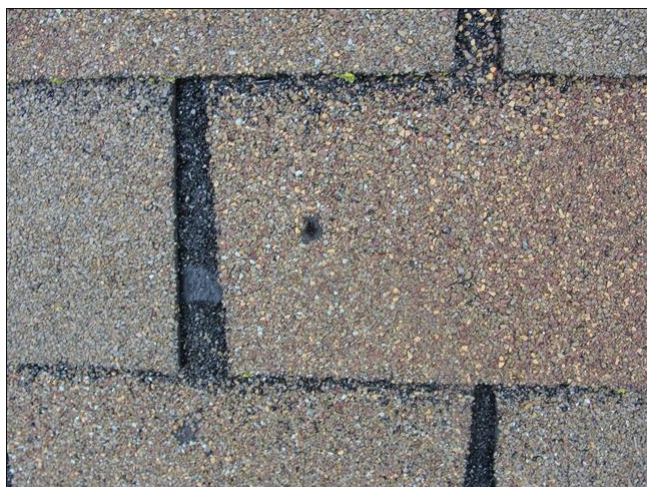
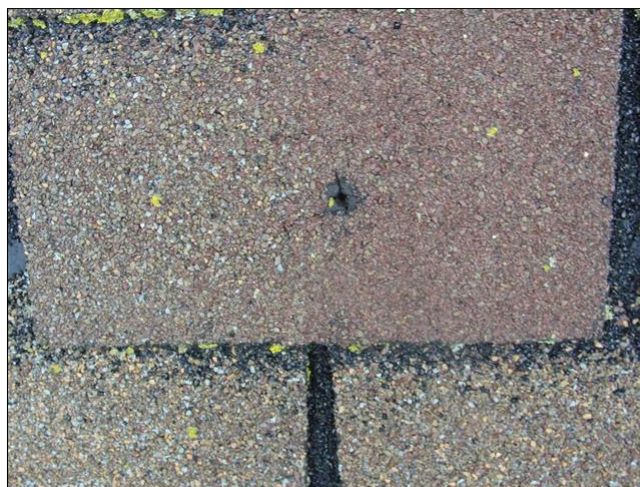
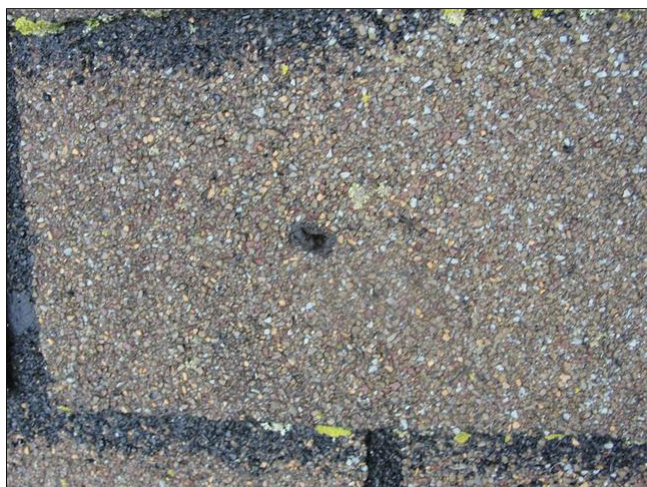
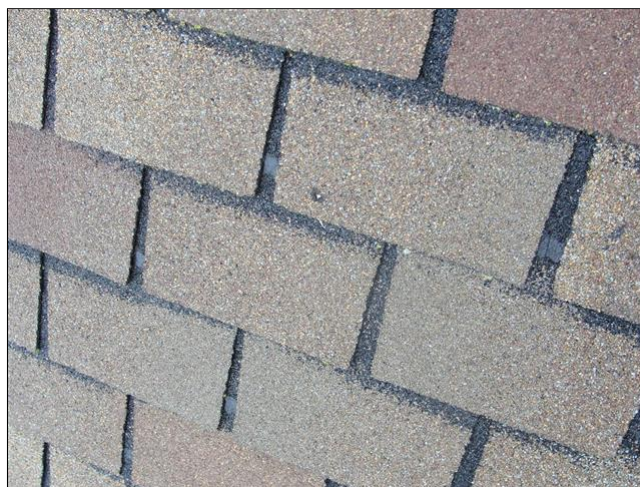
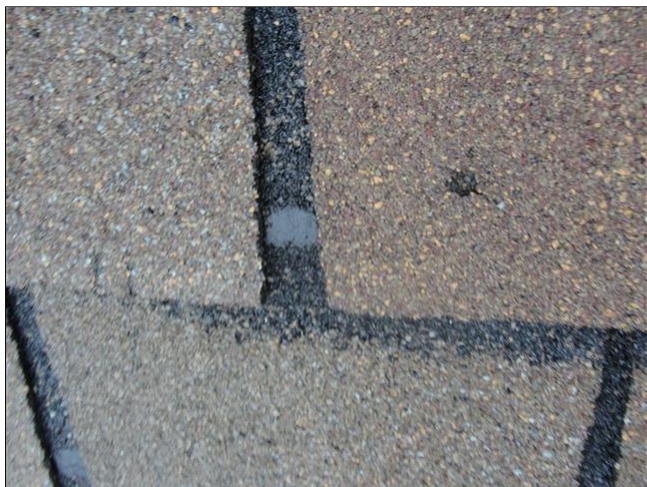
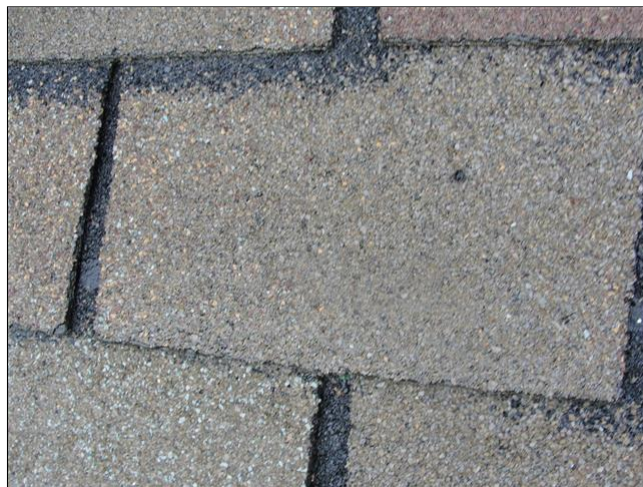
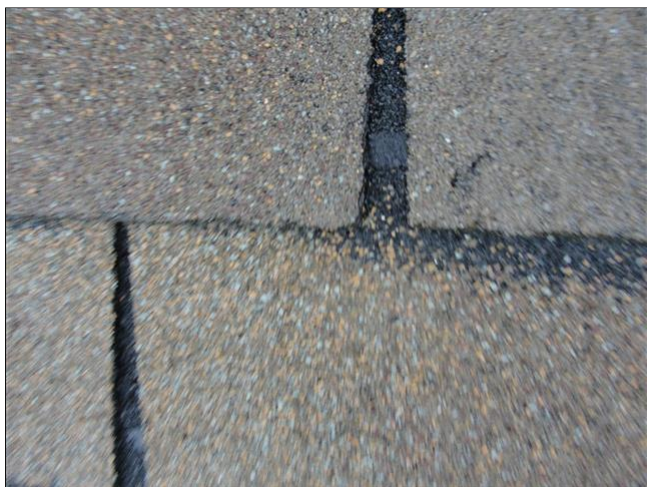
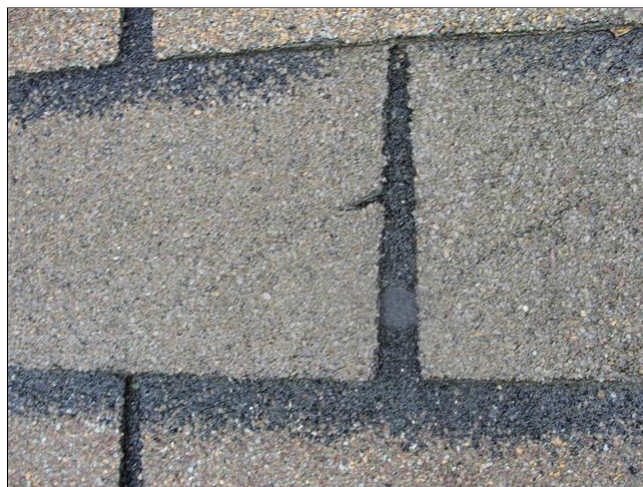
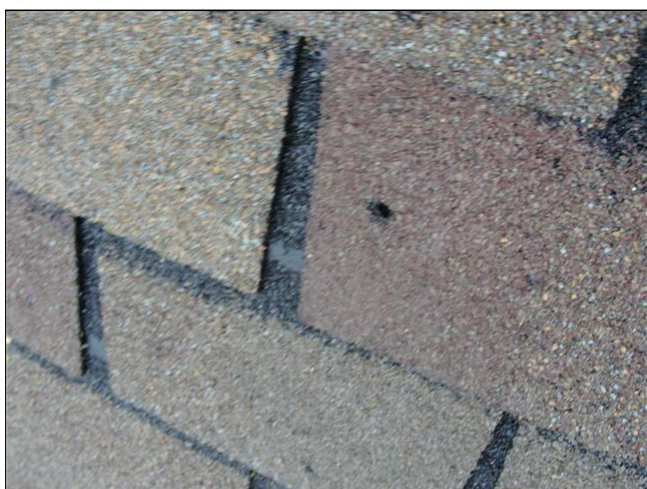
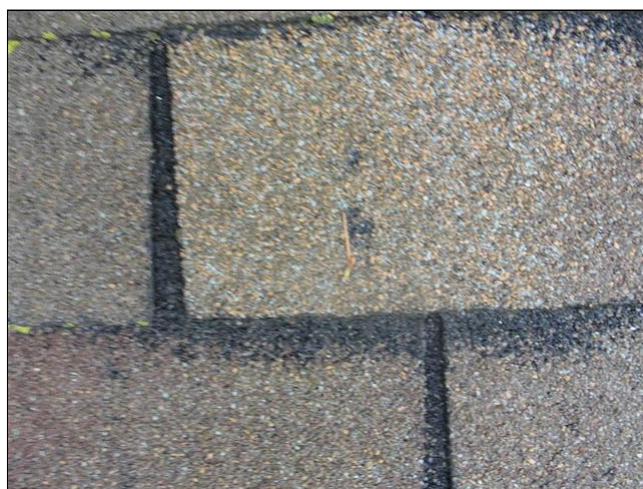
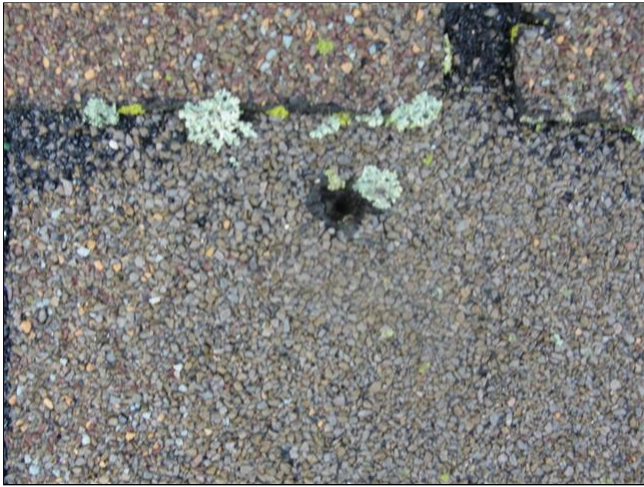
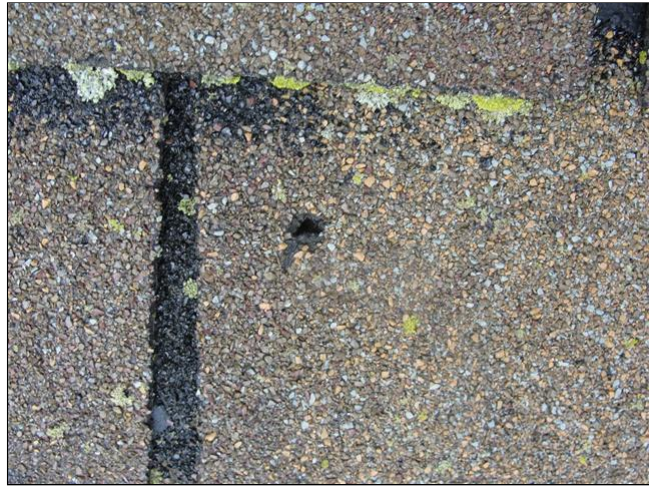
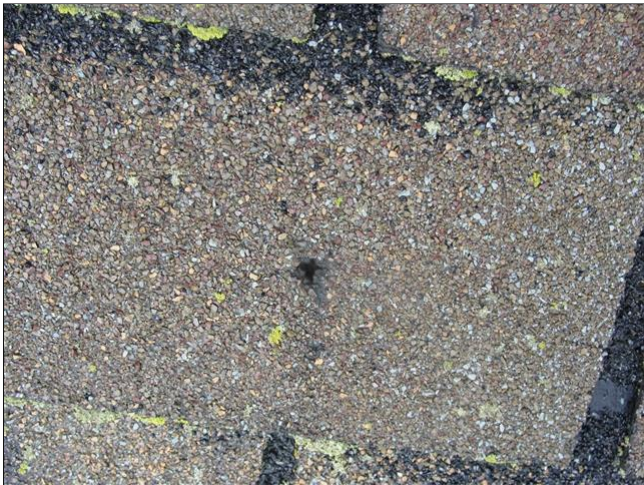
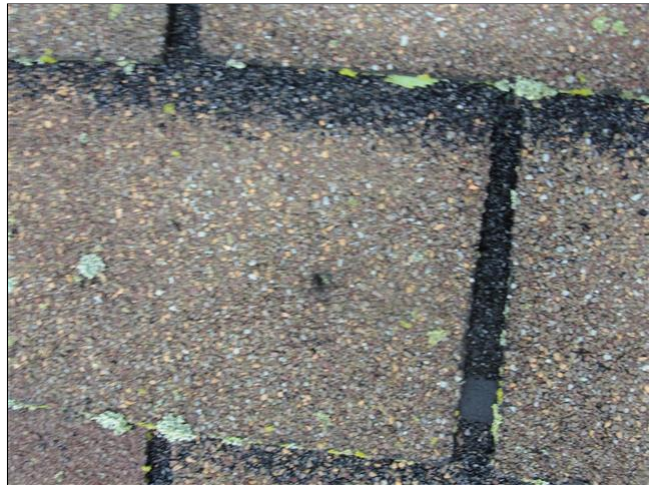
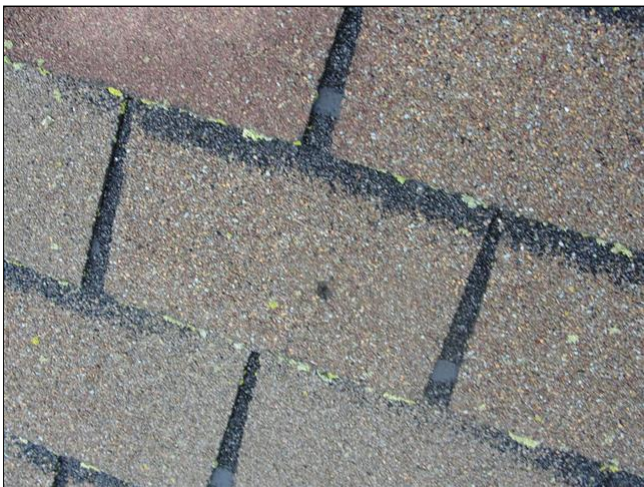
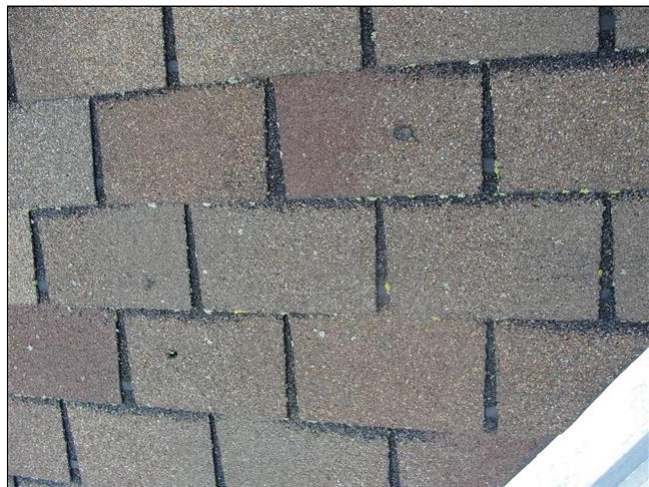
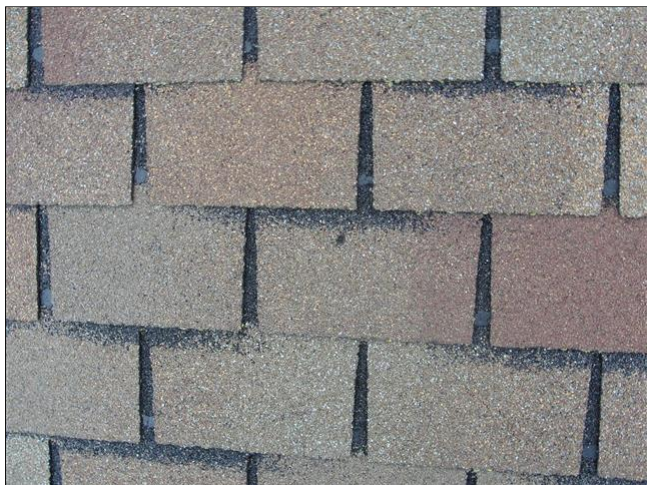
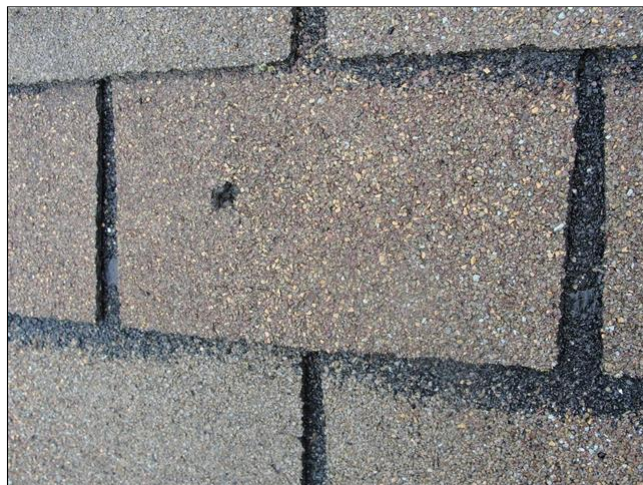
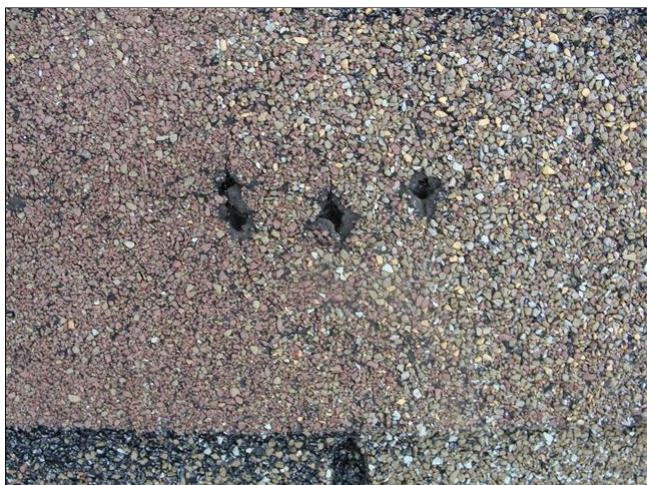
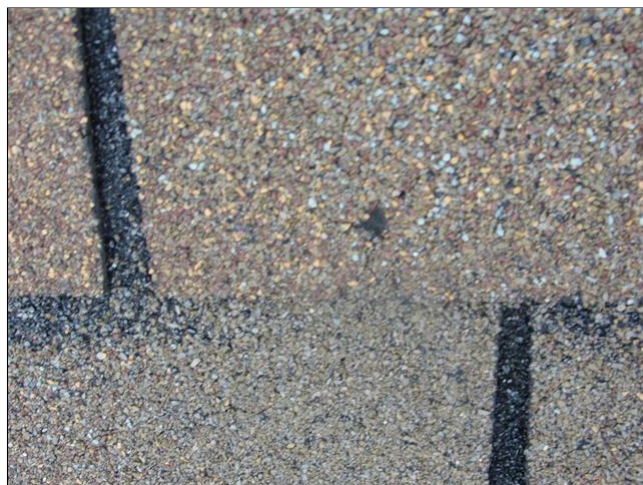
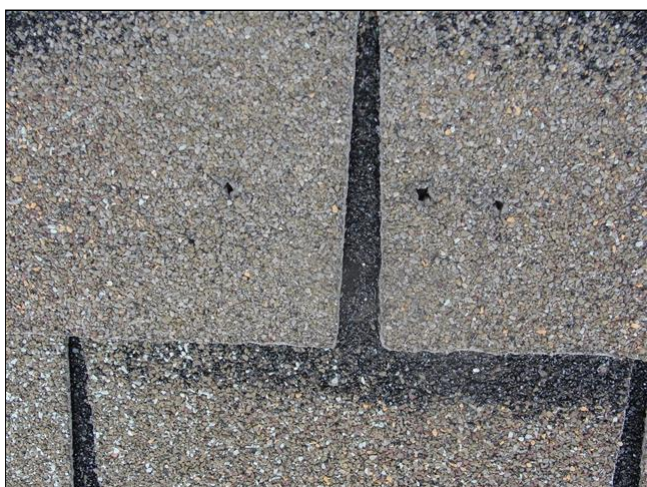
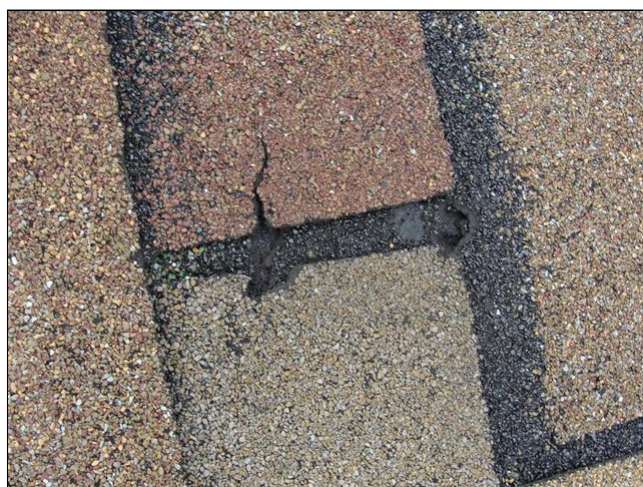
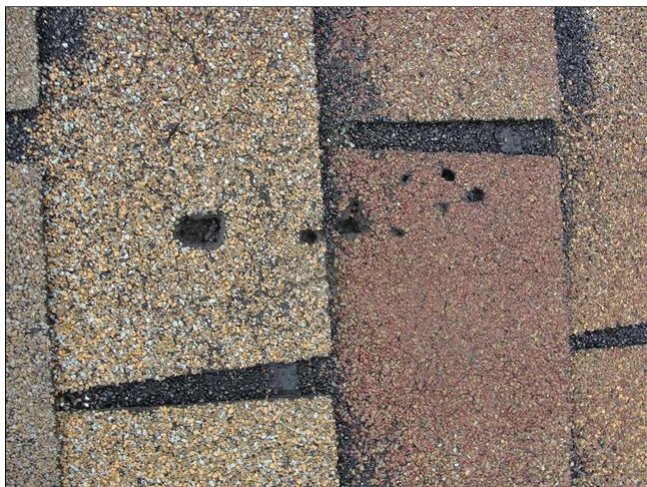
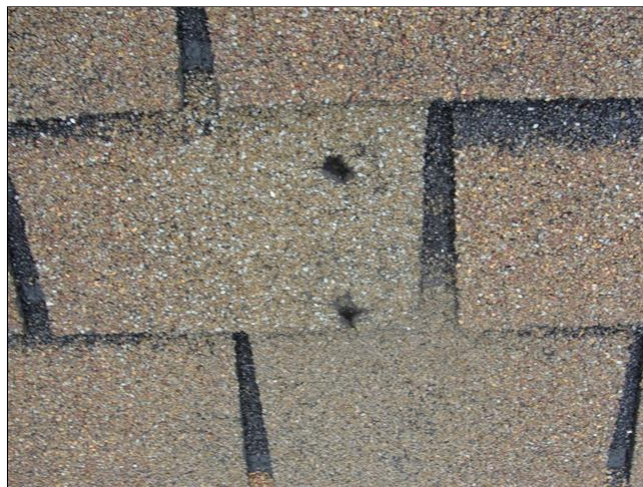
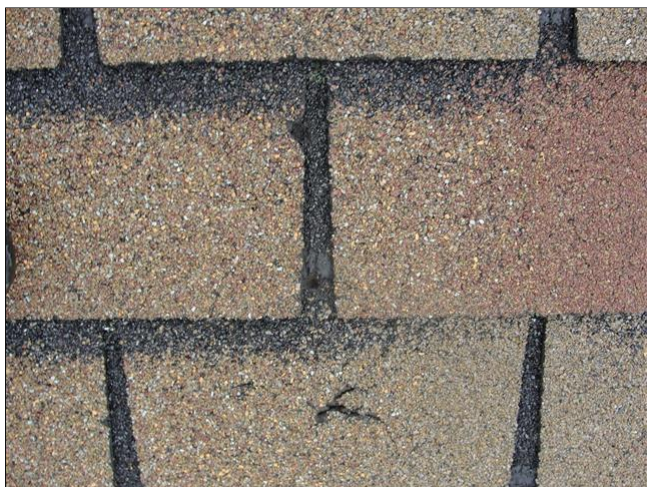
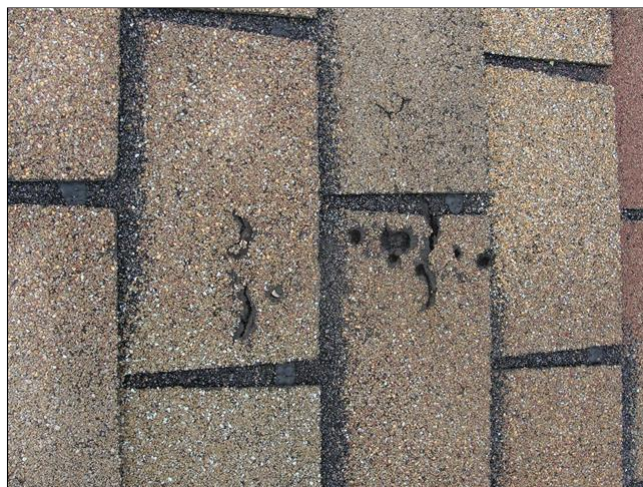
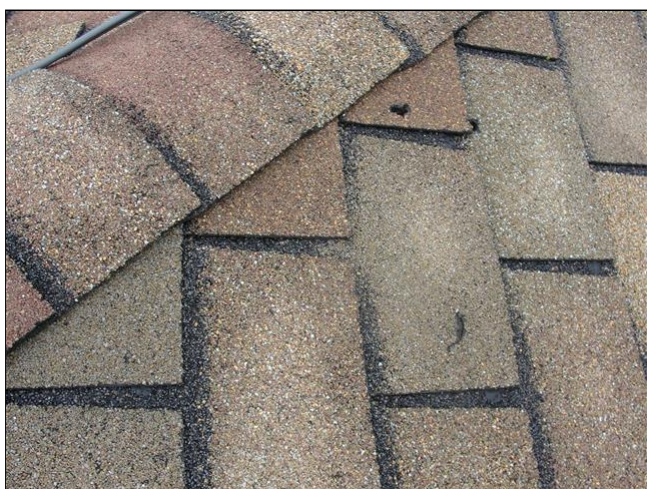
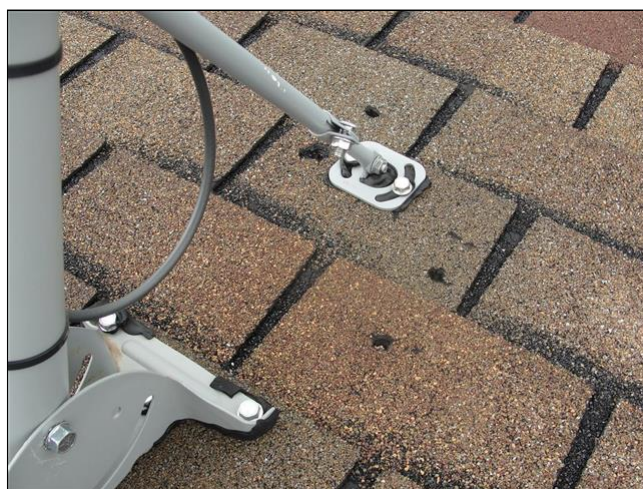
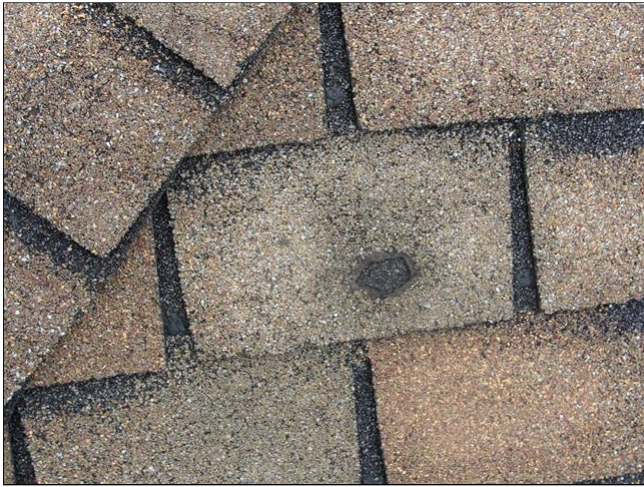
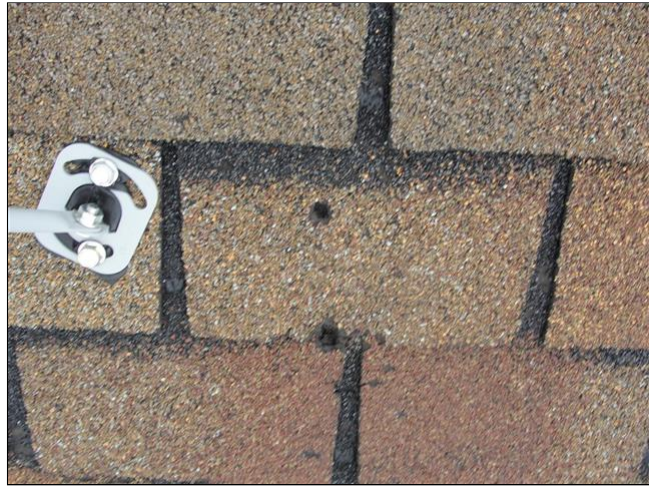
There were small holes in the shingles throughout the roof. These are all potential leak areas, and there were signs of leakage visible from the garage attic space. The shingles at the upper south side were severely deteriorated, which may indicate a defective shingle. Have the roof covering replaced.

Holes in shingles / damaged shingles

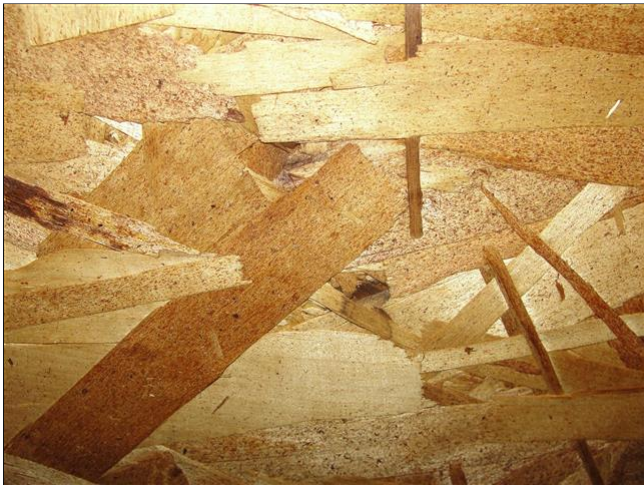
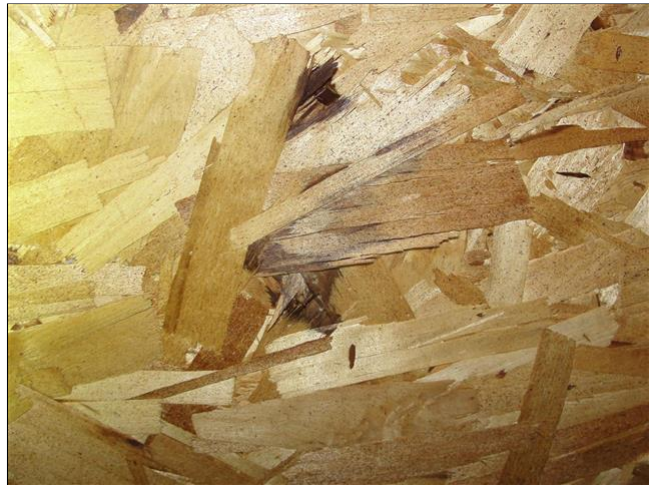
Stains on roof sheathing visible from garage attic

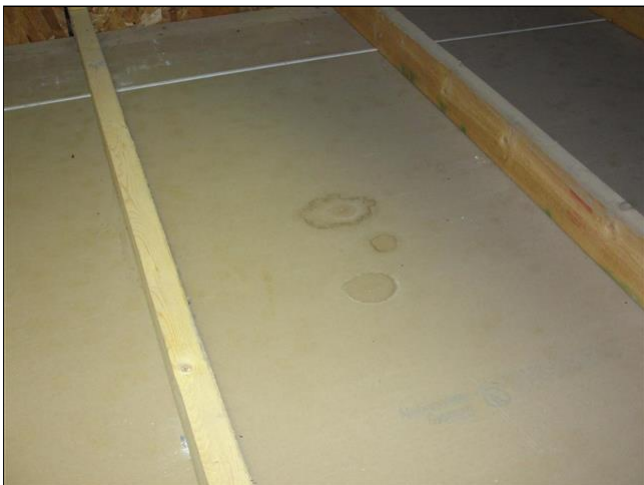
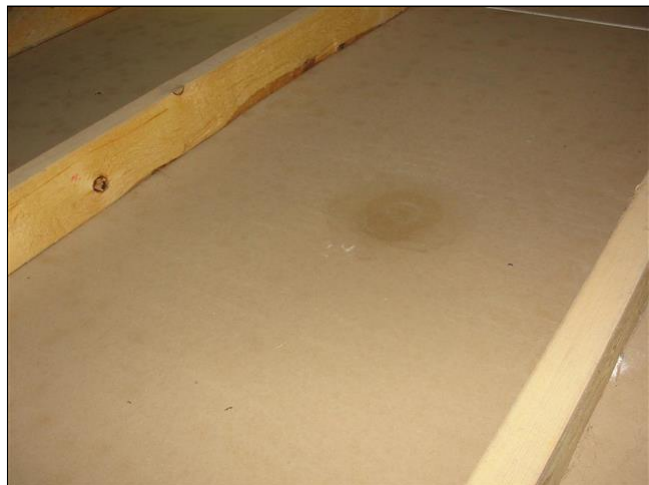
Stains below holes on garage ceiling

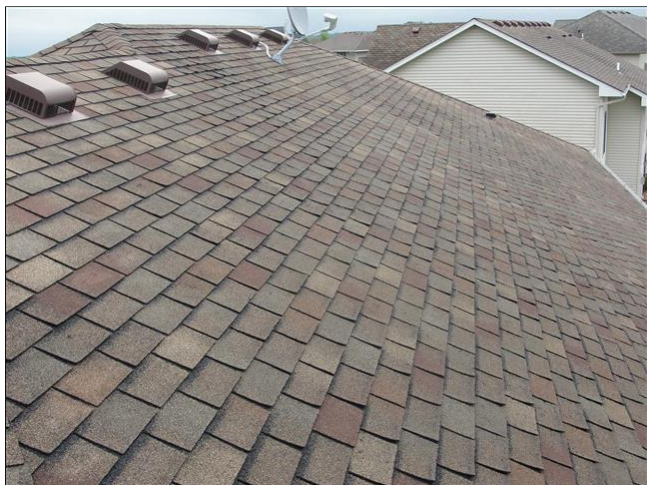
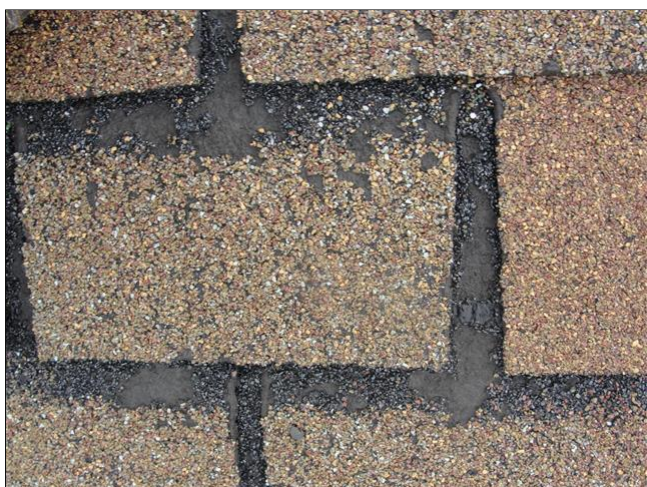
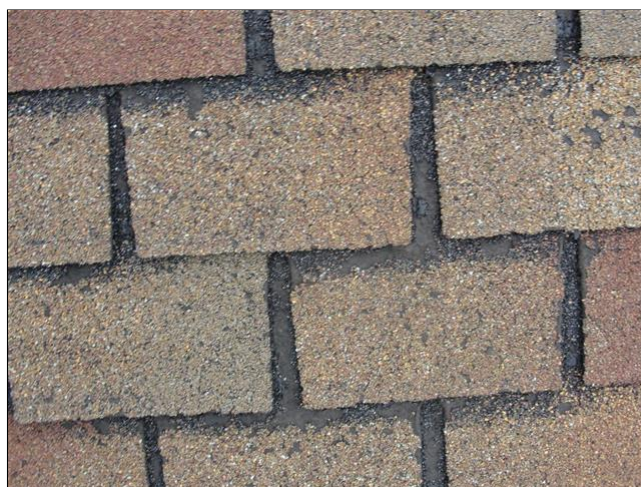
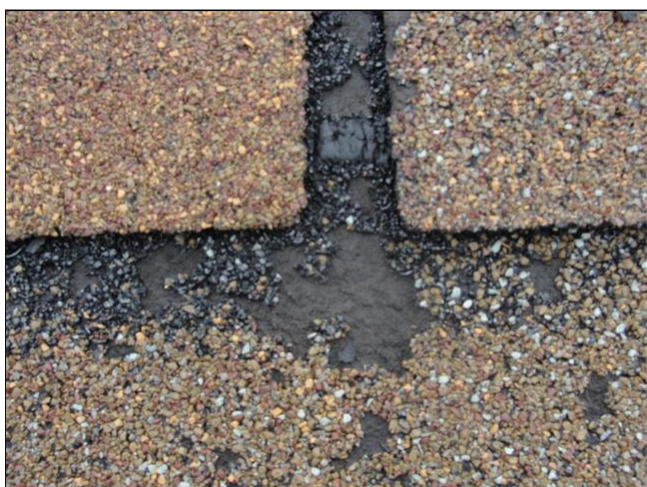
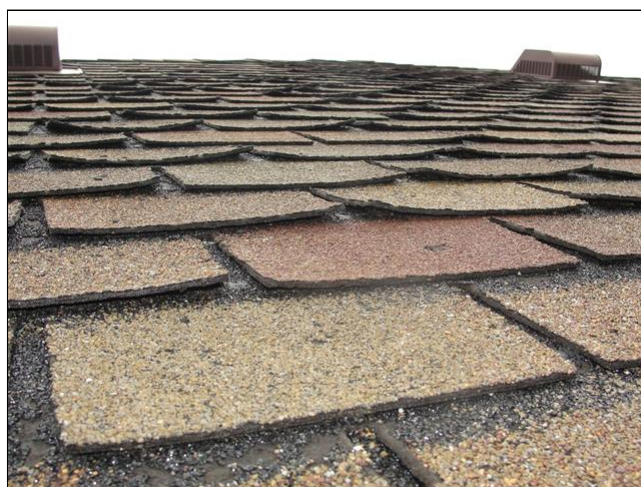
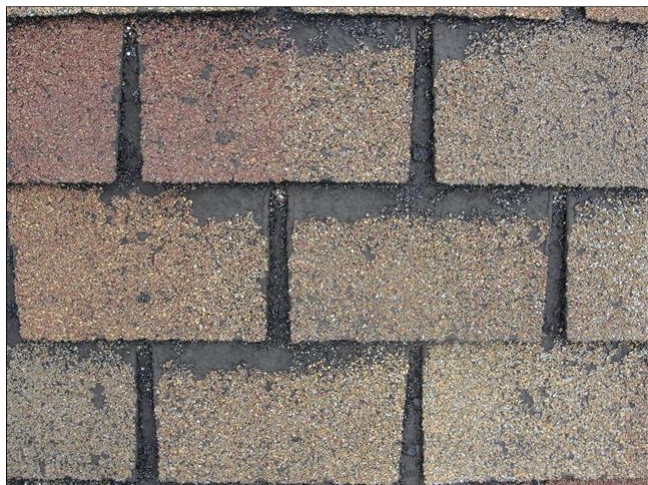
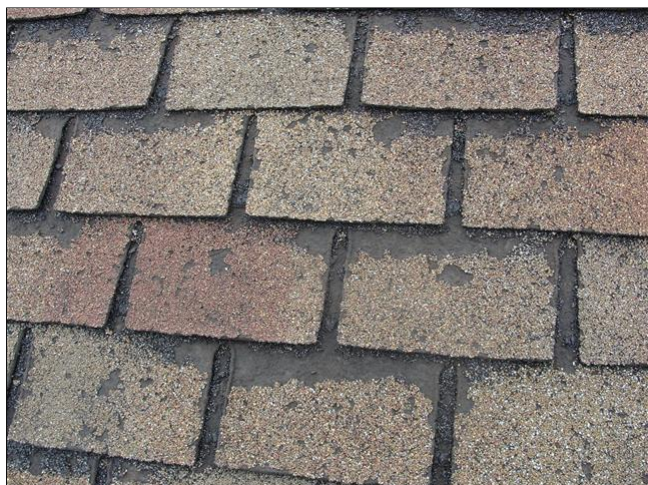
Deteriorated shingles

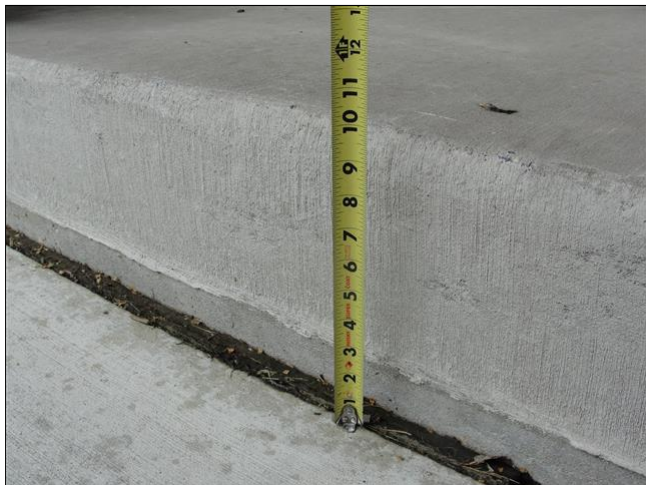
(1) The walkway has settled next to the front step, making for a high step to the front patio.

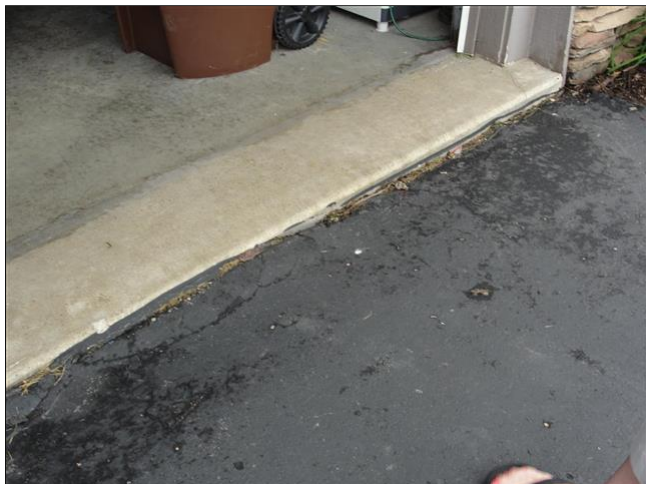
(2) The driveway has settled in front of the garage floor. This creates a trip hazard as well as a nuisance for vehicles pulling into and out of the garage. A new concrete or asphalt apron could be installed to create a smooth transition between the driveway and garage floor.

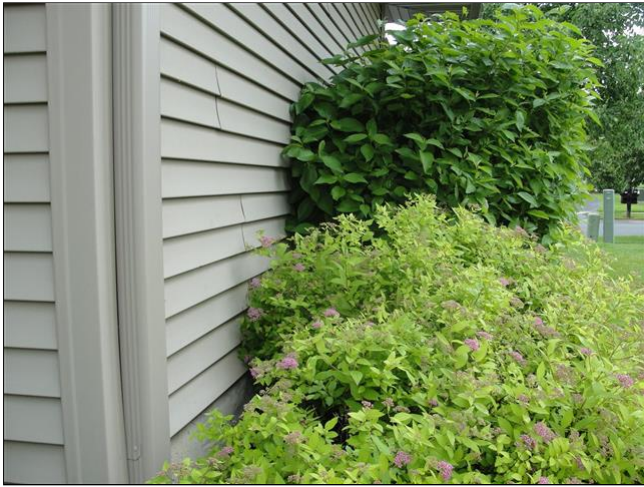
(1) Bushes were growing up against the house, but should be kept a minimum of twelve inches away for the general welfare of the walls and foundation. Trim the bushes back.

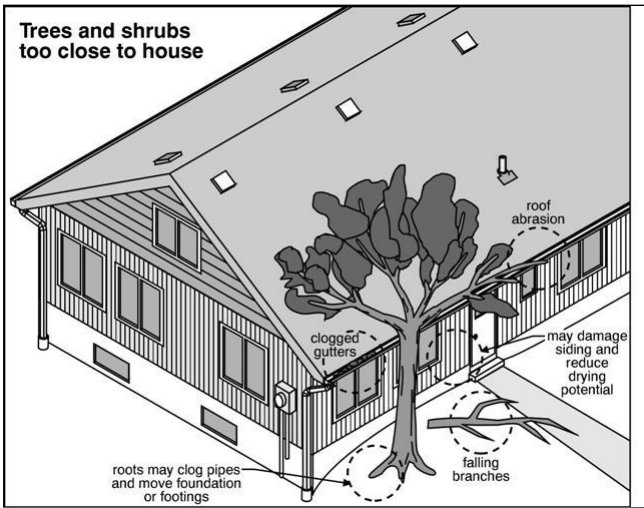
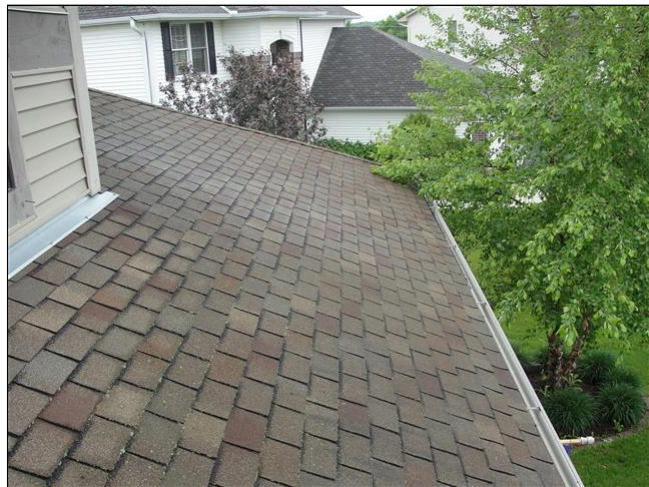
(2) There were tree branches in contact with the roof. Trees should be kept trimmed at least 6' away from the siding and roof to prevent damage to the building, and to help keep pests like squirrels and raccoons off the roof. Trim the tree branches back.

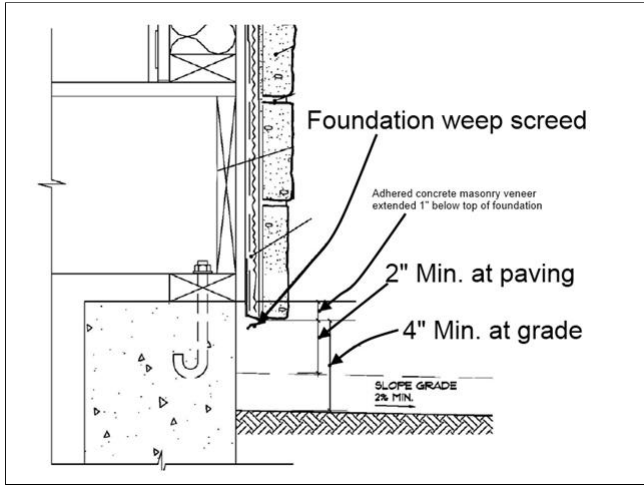
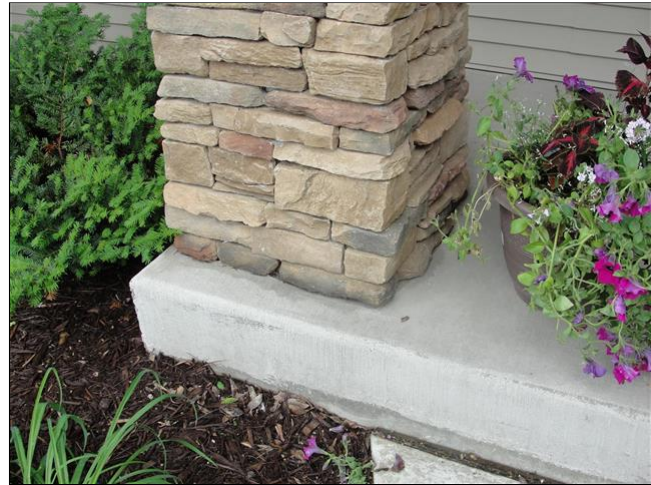
The adhered masonry veneer (stone siding) was improperly installed; there should have been a 2" gap left above the driveway and patio, and weep screeds installed to allow for proper drainage. There will be an increased potential for moisture damage, but this is a minor concern and there is no recommended service.

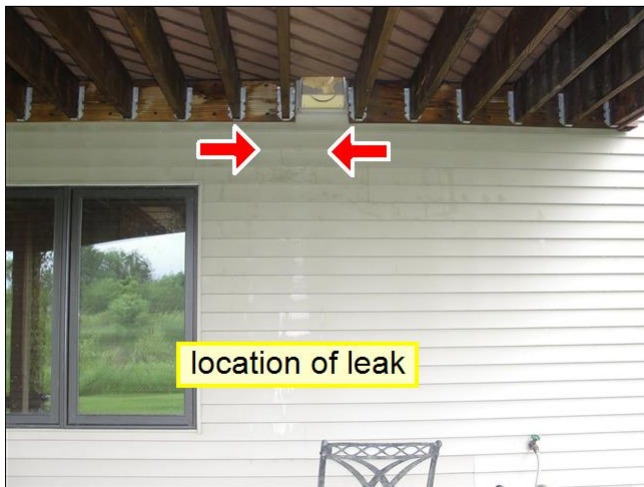
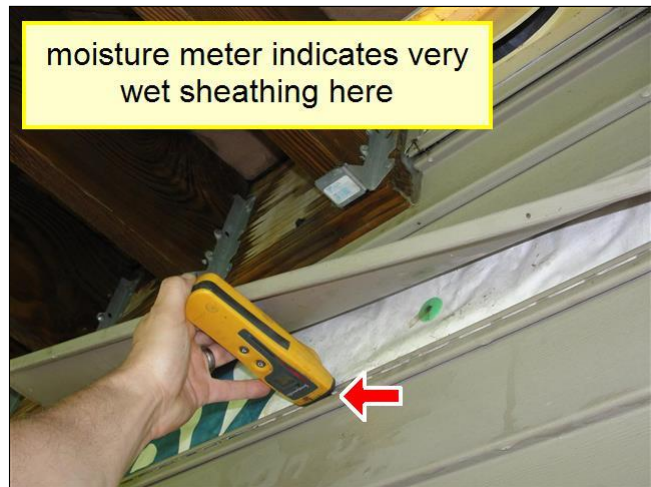
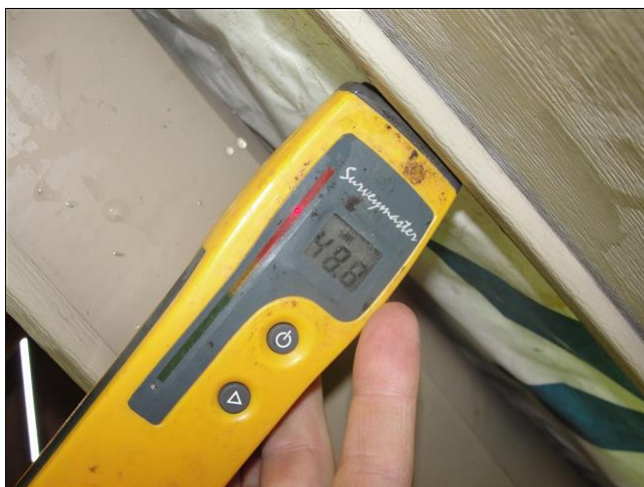
There was water intrusion at the deck roughly below the terminal for the kitchen exhaust fan. Have the siding and Tyvek removed at this location so the wall sheathing can be inspected and repaired if needed. Also, have the source of the water intrusion identified and corrected; this is most likely the result of an improper termination at the ledgerboard flashing.

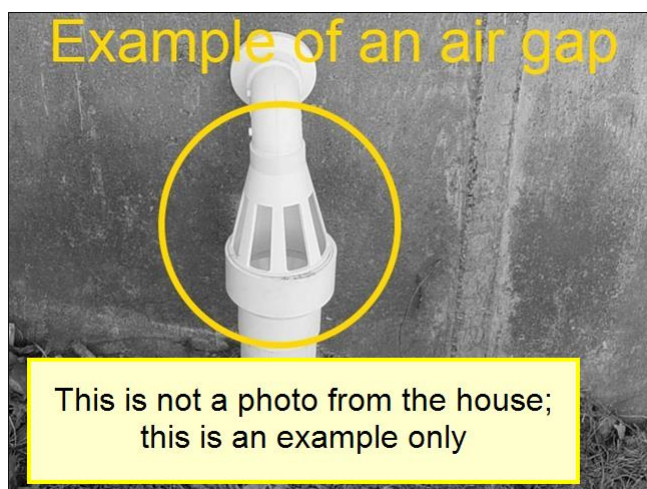
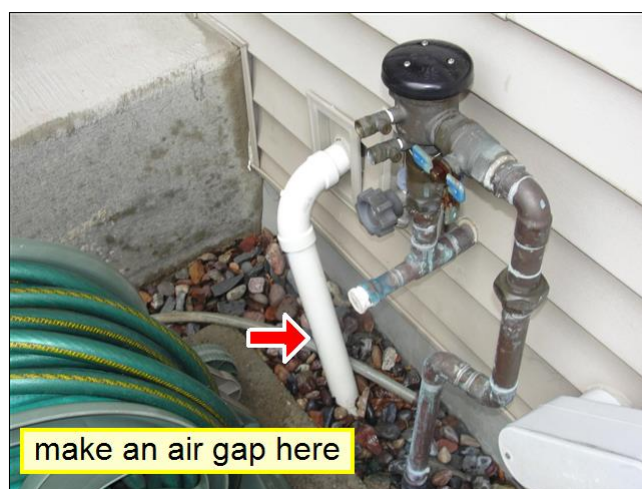
The sump pump discharge tube was directed below grade at the exterior. This has the potential to fill with ice and prevent the pump from functioning properly during the winter. Make an air gap at the exterior to help prevent discharge line from getting blocked.

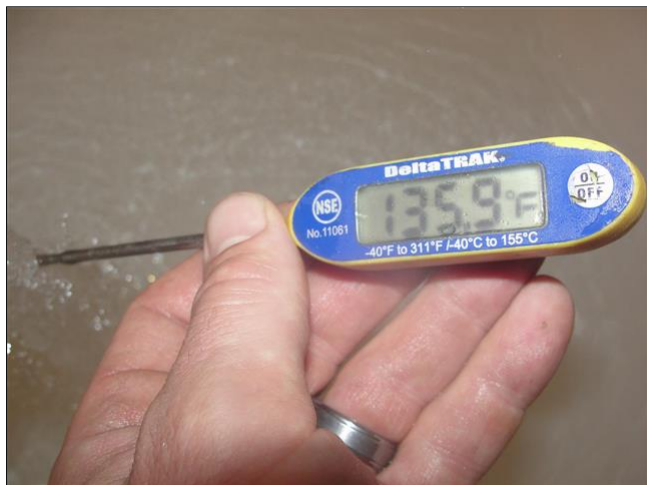
The hot water coming out of the faucets was measured at approximately 136 degrees, which can cause scalding very quickly. The temperature of the water shouldn't be higher than 120 degrees at any of the faucets. To reduce the risk of scalding, turn the temperature down at the water heater. Be aware, however, that this will increase the potential for Legionellae Bacteria growth. To minimize the risk of scalding and bacteria growth, have a tempering valve installed. For more info on this topic, click here: [Water Heater Temperature](#).

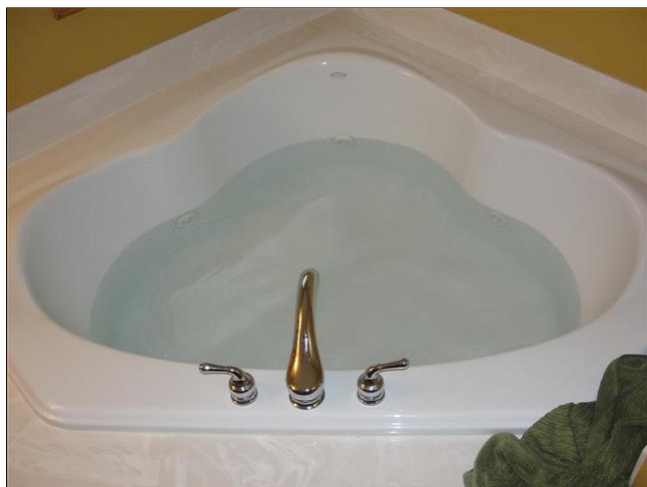
The water heater is a 50 gallon unit, which isn't large enough for the bath tub. This might be why the temperature was turned up to an unsafe level at the water heater. To read more about this particular issue, click here - [Water Heater Sizing](#).

large tub

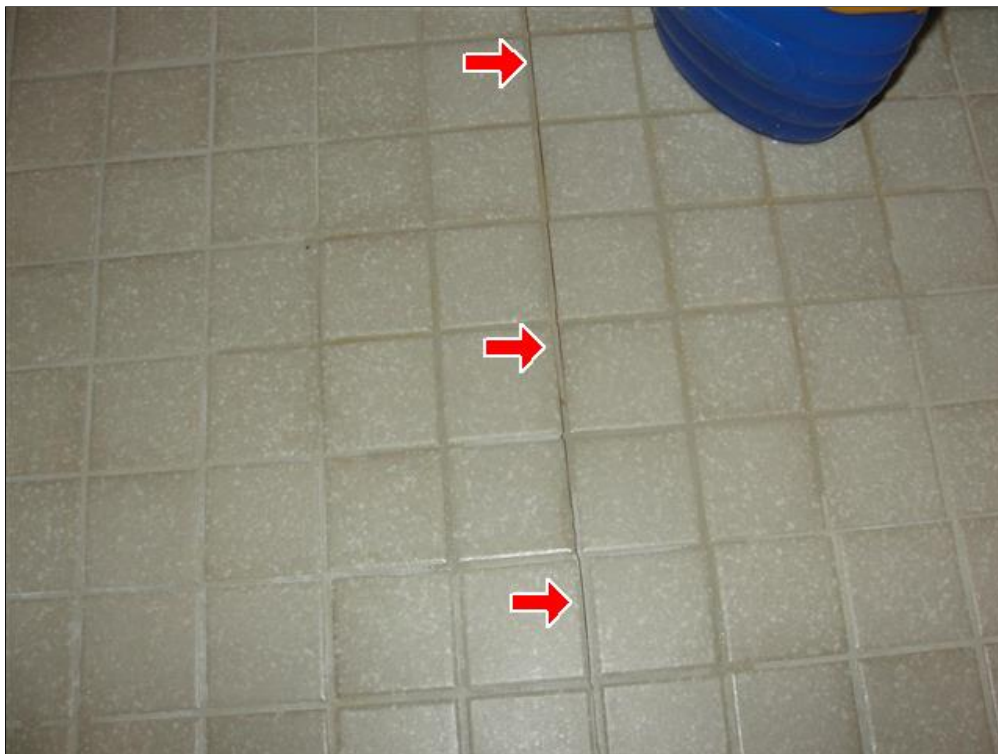
(1) There were a few hairline cracks in the grout at the tiled shower floor in the master bathroom. These are of little concern. I tested the shower by flooding the shower base with 2" of water, and left the water in the base for approximately one hour. There were no leaks.

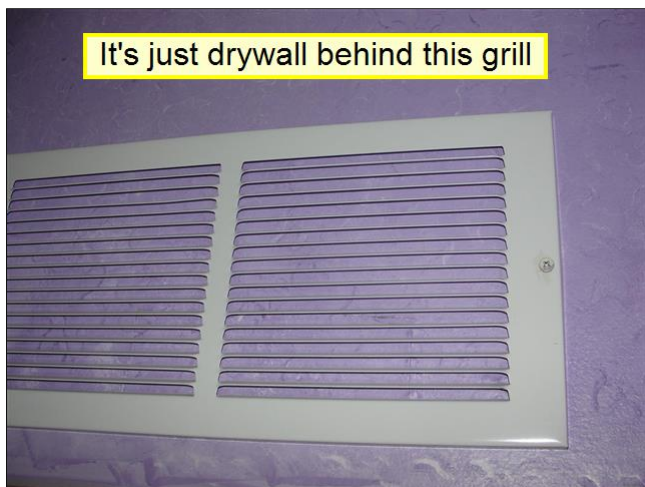
(2) There was no access panel provided for the second floor hallway bath tub drain. If the drain needs to be accessed, a hole will need to be cut in the wall or ceiling.

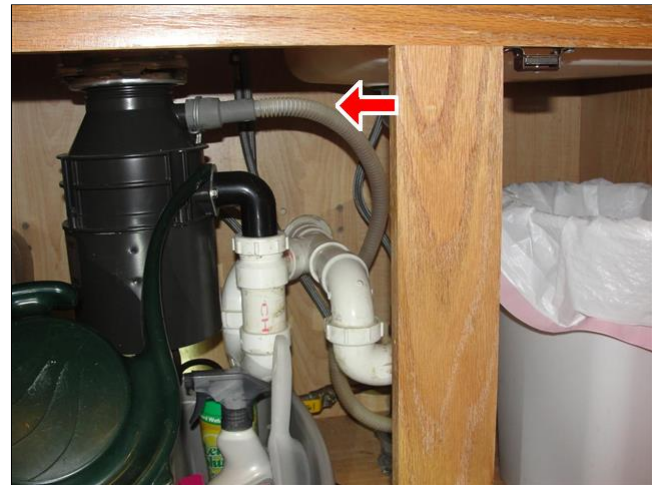
The kitchen dishwasher drain did not have a proper high loop to prevent water from siphoning back into the dishwasher. This could lead to a cross-connection with the city water supply or a clogged dishwasher drain hose. Raise the dishwasher drain hose to match the diagram below. To read more about this specific issue, click here: [high loop at dishwasher drain](#).

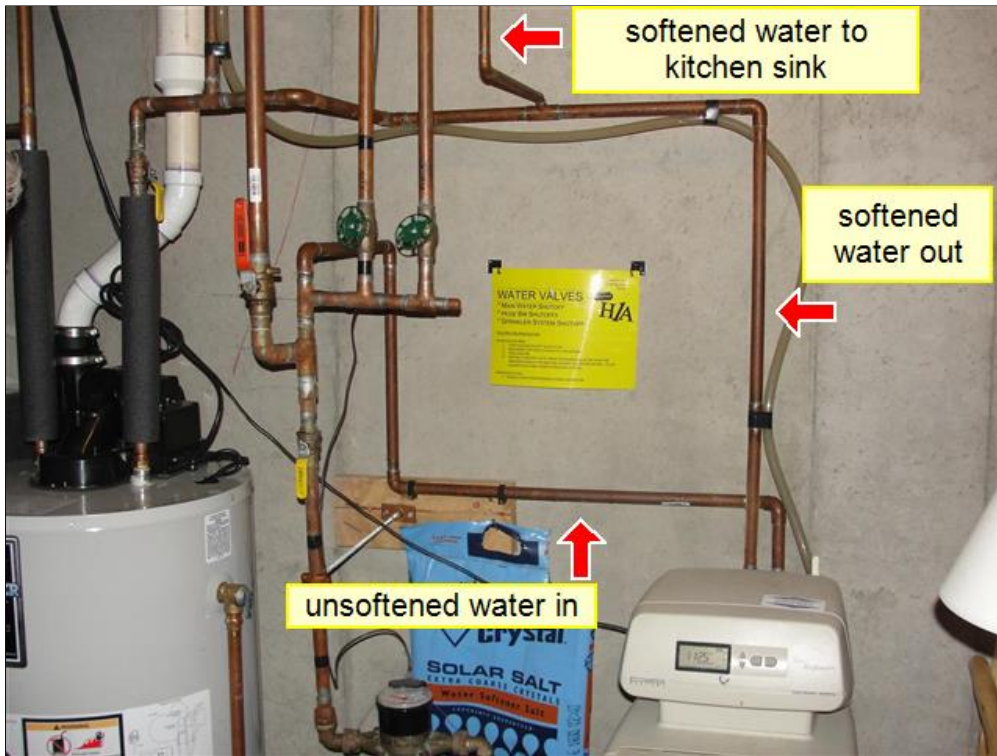
All of the interior plumbing fixtures were plumbed with softened water, however, the cold water line to the kitchen sink faucet typically bypasses the water softener. It appears that the house was plumbed for this, but the softener was plumbed *before* this separate line, not *after* it.

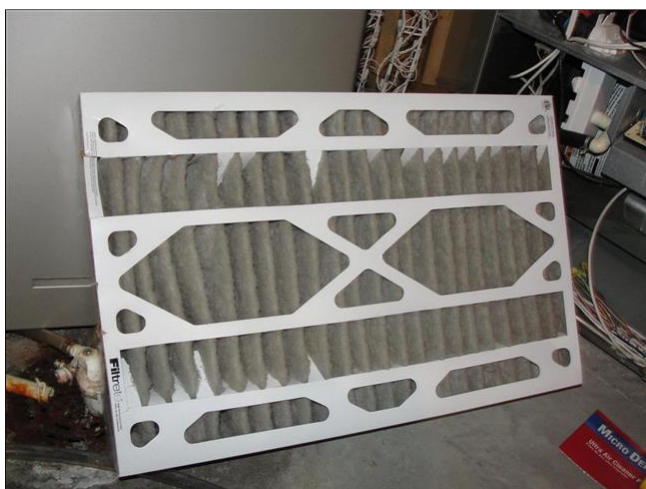
The furnace filter was extremely dirty and should have been changed a long time ago. A dirty filter means restricted air flow, which means less heat gets dissipated from the heat exchanger, which could lead to premature failure of the furnace. Have the filter changed ASAP. For more info on the importance of changing furnace filters, click here: <http://www.structuretech1.com/blog/category/furnace-filters/>

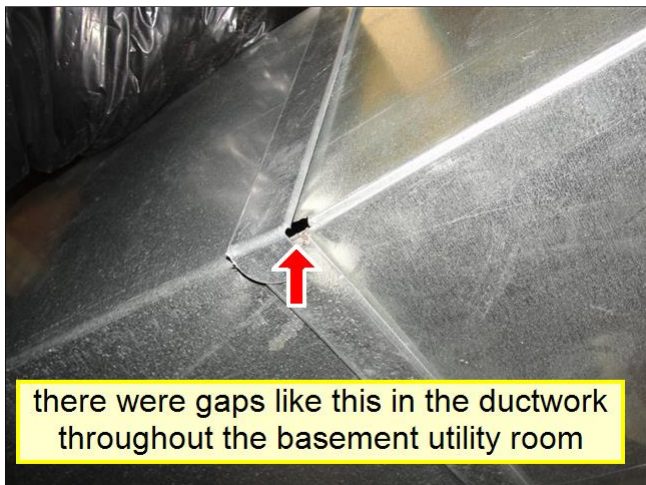
(1) There were various gaps in the metal ductwork for the furnace that should be sealed with metal tape to help prevent unwanted air leakage in to the basement, and to help prevent air in the basement from getting sucked out and distributed throughout the rest of the house. Sealing these air leaks will help get more air where it's supposed to go, which helps to keep the house more comfortable.

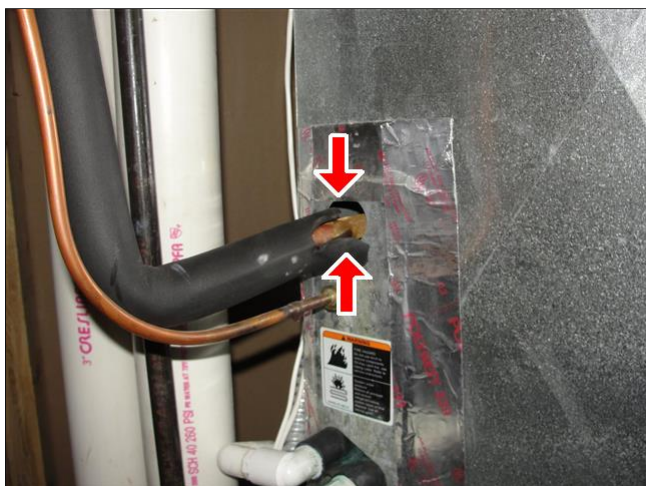
(2) There was a large gap at the supply ductwork where the AC lines enter in to the evaporator coil above the furnace. Have this gap repaired to help prevent unwanted air leakage.

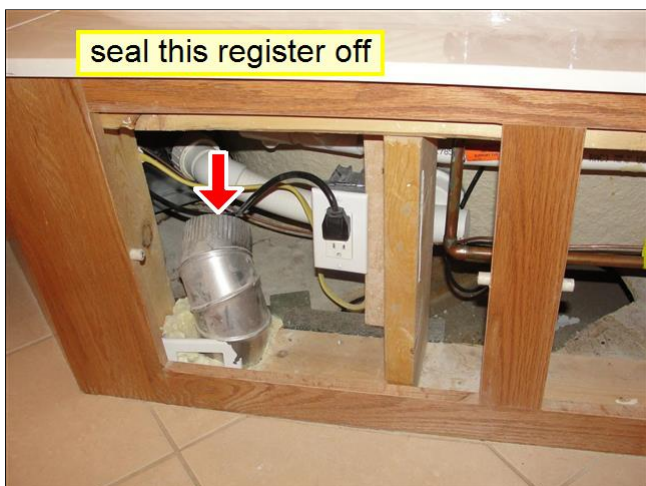
There was a register under the master bathroom bath tub. While it may seem like a good idea to heat this area to keep the tub warmer during the winter, this will also increase the potential for moisture problems at the exterior walls, because it ends up pressurizing this dead space. Have this register sealed over.

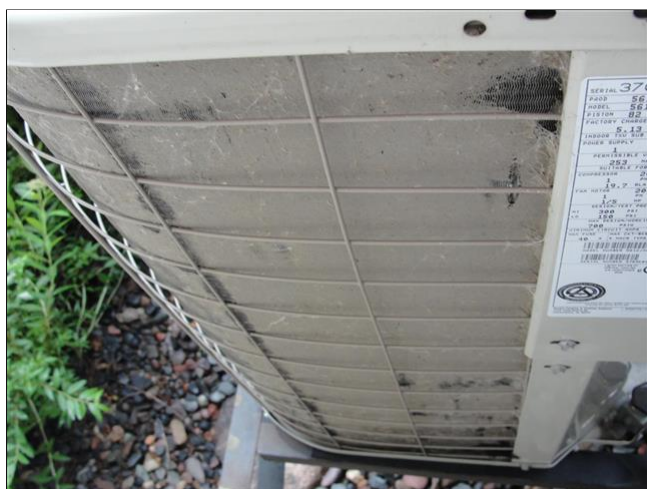
The condensing coil was dirty, which will reduce the efficiency of the unit. [Clean the condensing coil](#).

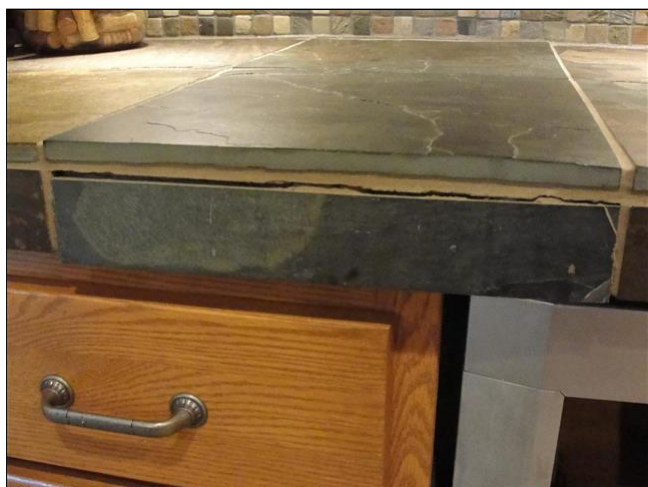
There was one loose tile at the basement bar countertop.
