General Summary

Structure Tech Home Inspections

Inspection Address
12345 Any Street
Minneapolis MN

Inspection Report

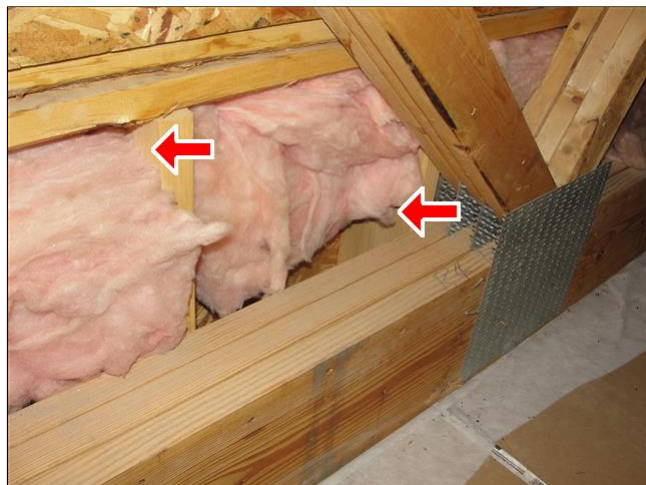
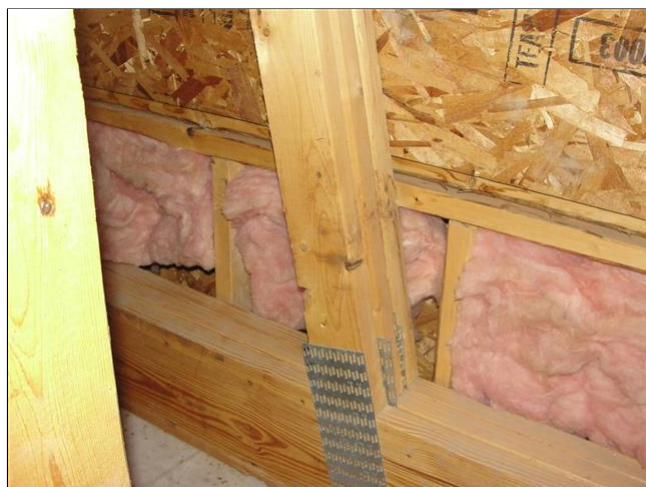
The insulation at the rim space between the first and second floors was incomplete in the garage, and should be re-done to help reduce energy loss at this location.

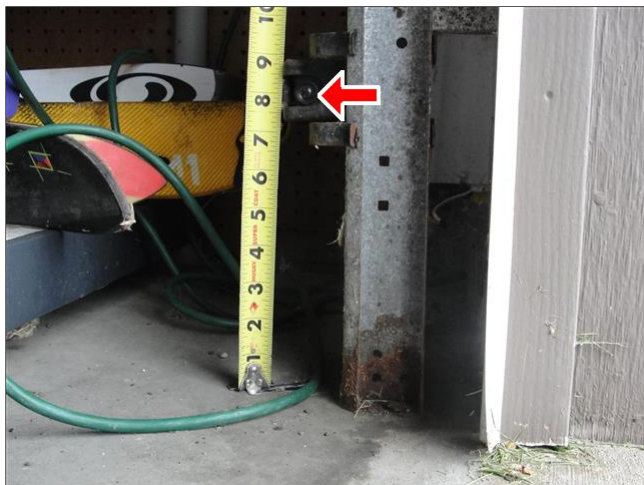
(1) The safety-reverse sensors for the garage door opener were located higher than six inches above the floor, which is the maximum allowable height. Lower the sensors for safety.

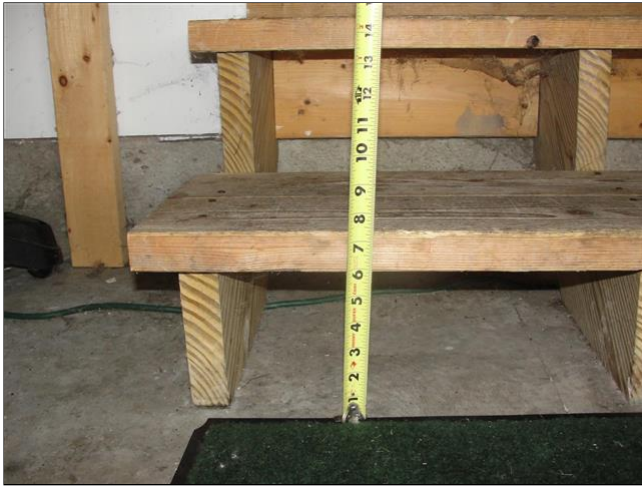
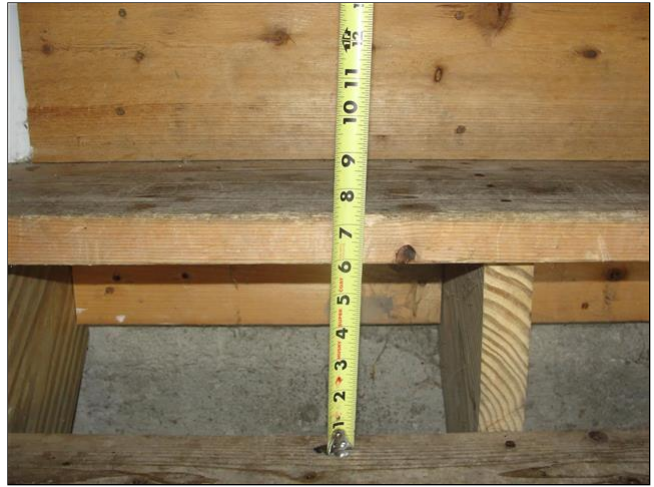
The steps at the garage stairway had uneven riser heights. Steps should have uniform heights to help prevent trip-hazards.
