# Structure Tech Home Inspections

## SUMMARY REPORT

**Client:** New Home Buyer  
**Inspection Address:** 123 Perfection Street, Minneapolis, MN  
**Inspection Date:** 11/2/2011 Start: 8:30 am

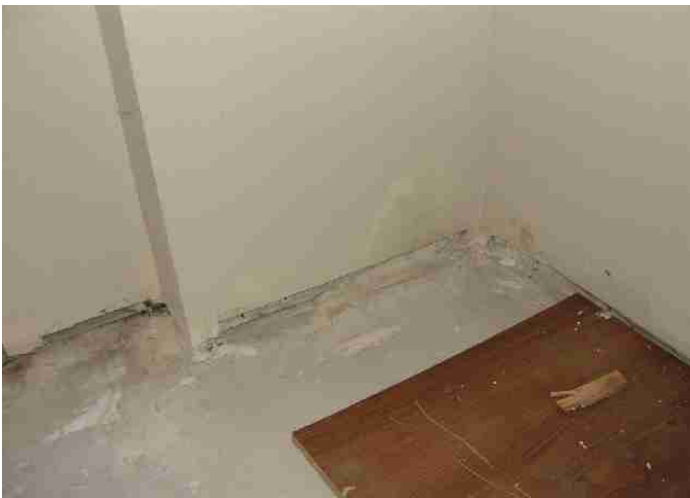
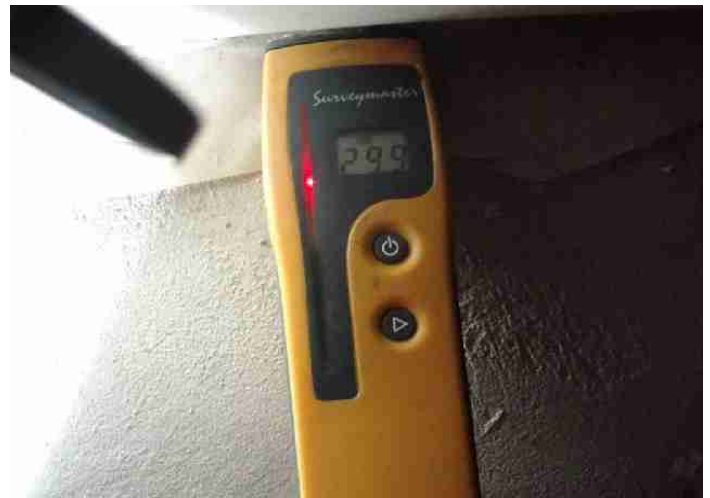
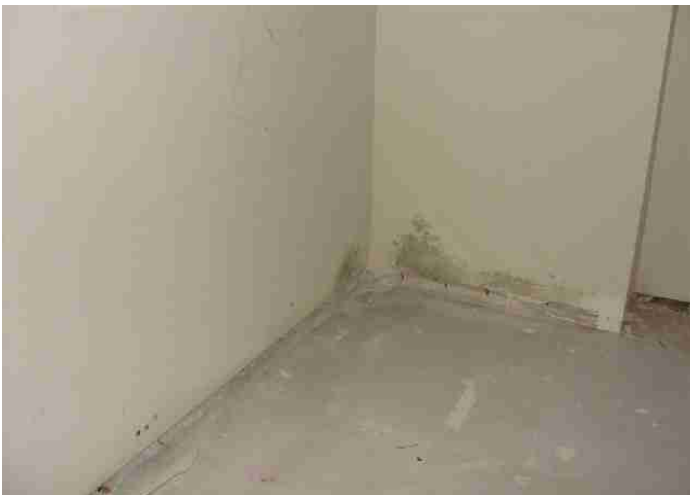
There was an unacceptably high moisture level in the wood wall plates underneath the stairway - as high as 30% in some areas. There was also staining on the walls that appeared to be mold growth. Have the drywall in this room completely removed and have a disaster repair company run a dehumidifier in this area for as long as it takes to get the moisture levels back down to an acceptable level.

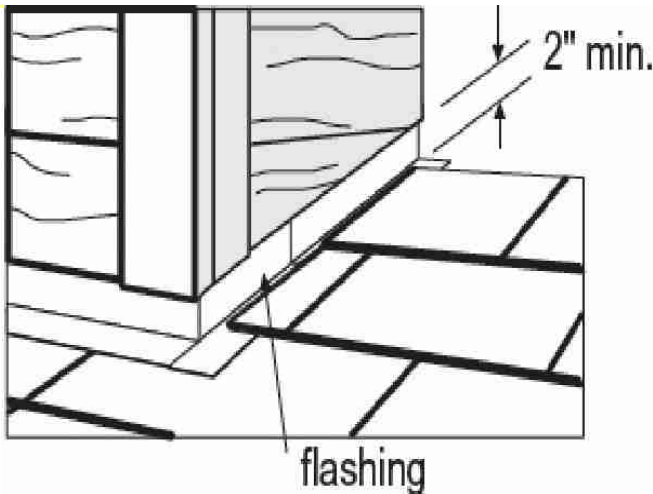
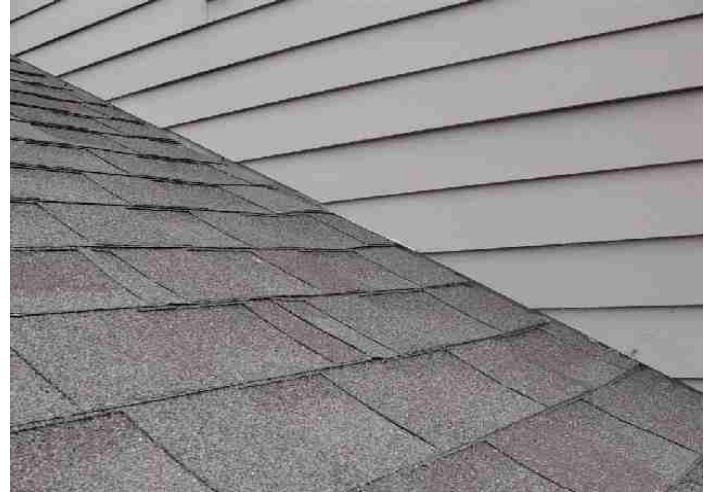
The fiber cement siding was installed too close to the roof. The siding should have been kept 2" above the roof surface to help prevent premature deterioration of the siding and peeling paint.

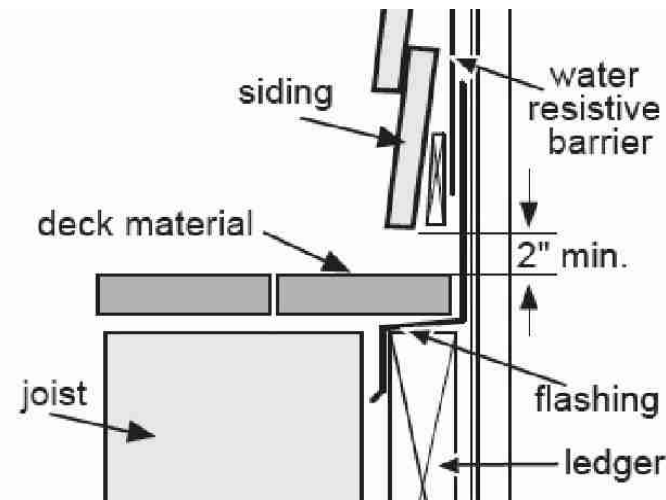
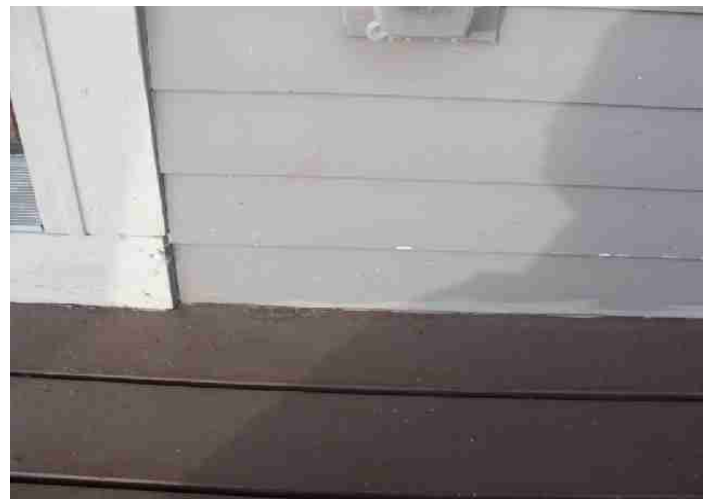
The fiber cement siding has been installed too close to the deck surface. The installation instructions require a 2" gap. The siding will be prone to damage and peeling paint here.

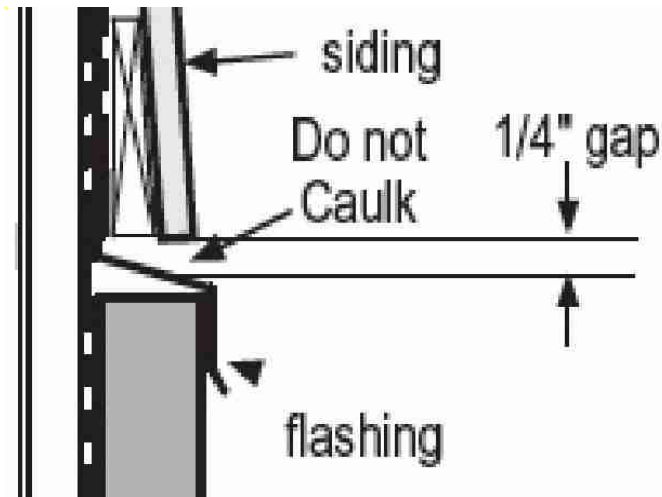
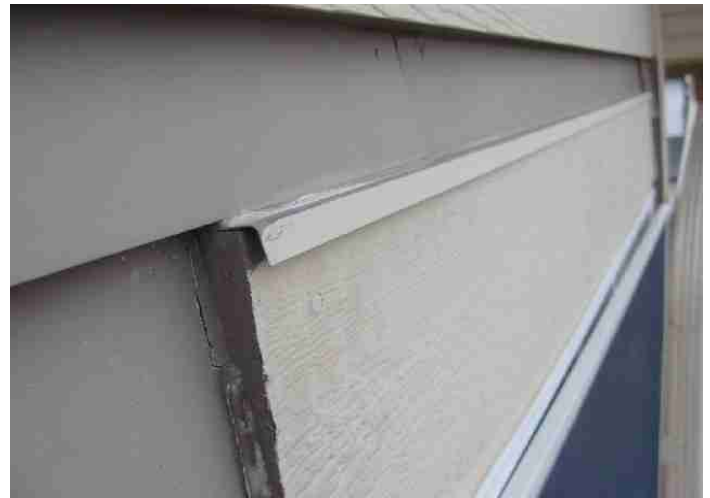
The siding has been caulked where it ends above the windows and doors, but this is prohibited by the manufacturer, as water could get trapped above the window. For more information on this topic, visit <http://www.structuretech1.com/blog/category/caulk-at-head-flashing-2/>

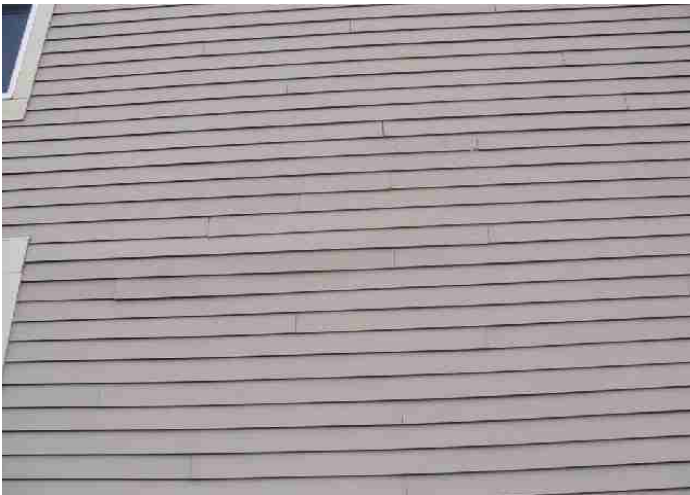
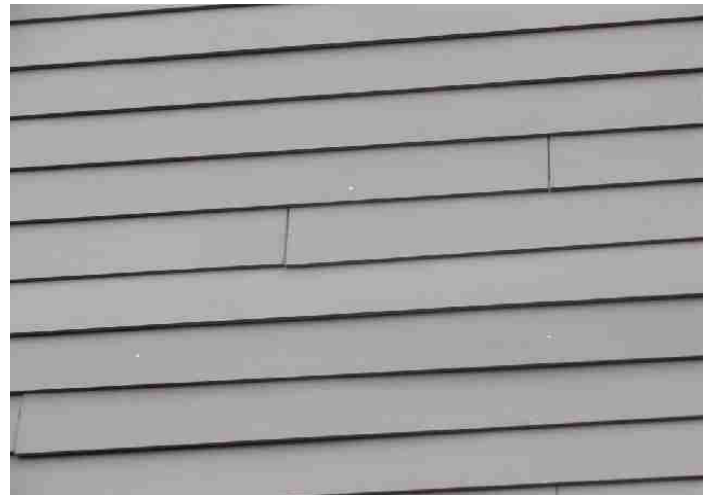
The siding has been blind nailed and face nailed in the middle of the south wall, which is prohibited by the manufacturer. The siding can be blind nailed OR faced nailed, but not both. The siding will be prone to cracking with this improper installation. Why were all of these extra face nails added? Did the siding come loose here? I suggest you ask the seller about this.

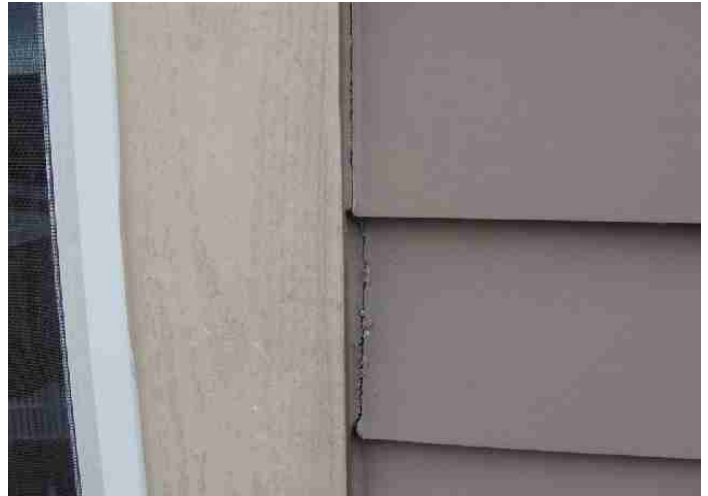
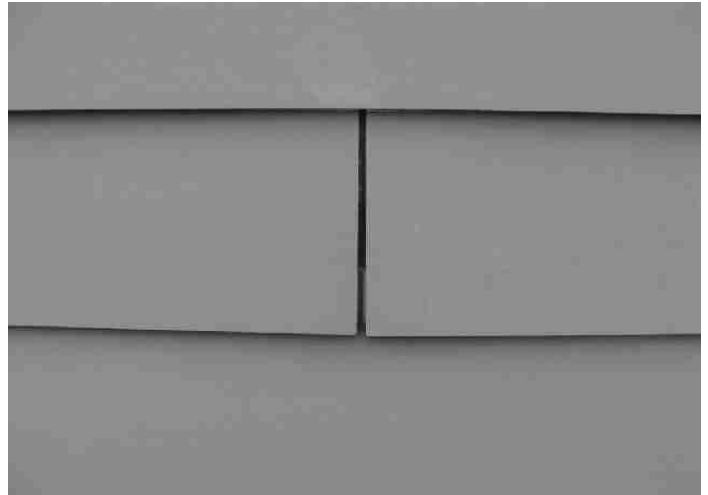
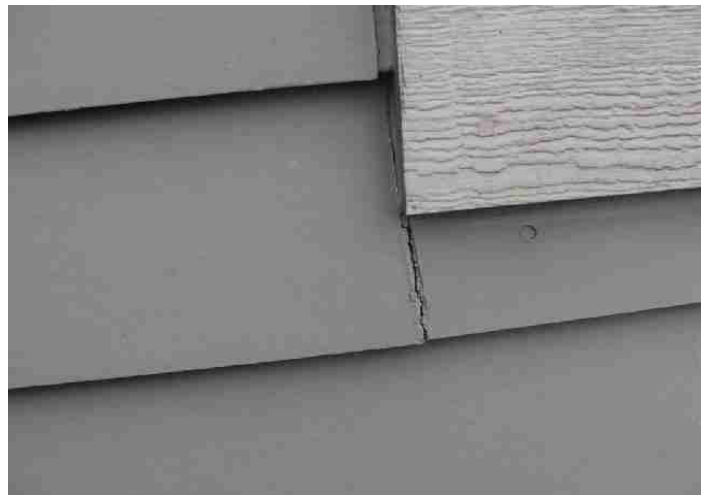
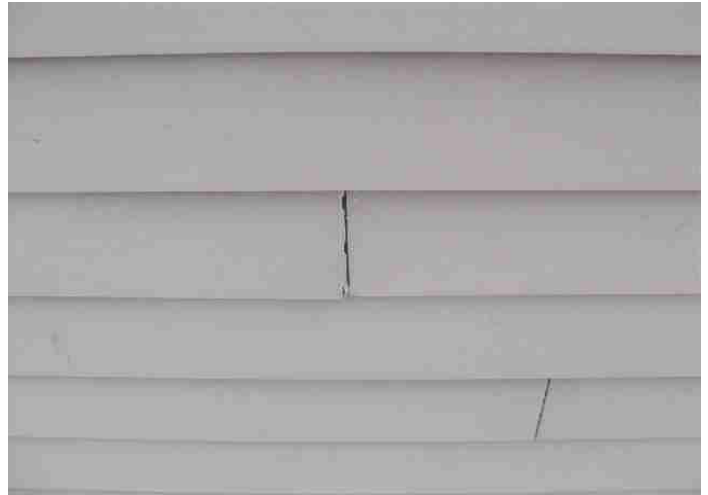
There were open joints at the hardboard siding throughout the exterior, and these joints either don't have any joint treatment at all, or they were caulked and the caulking has dried out and split. The caulking has also dried out and split where the siding ends at windows and other trim pieces. The siding will be prone to water intrusion with all of the open joints. Have the siding serviced.

Open joints with split caulking - *Continued*

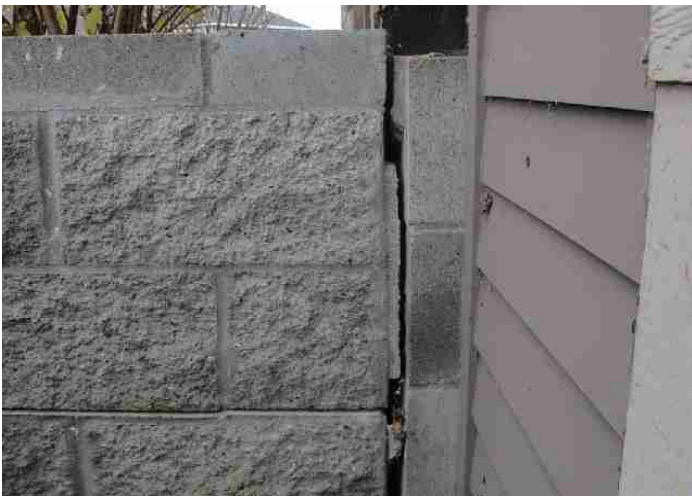
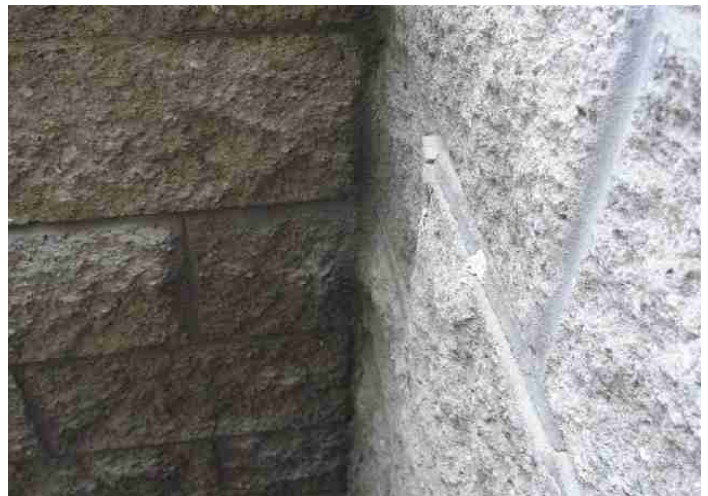
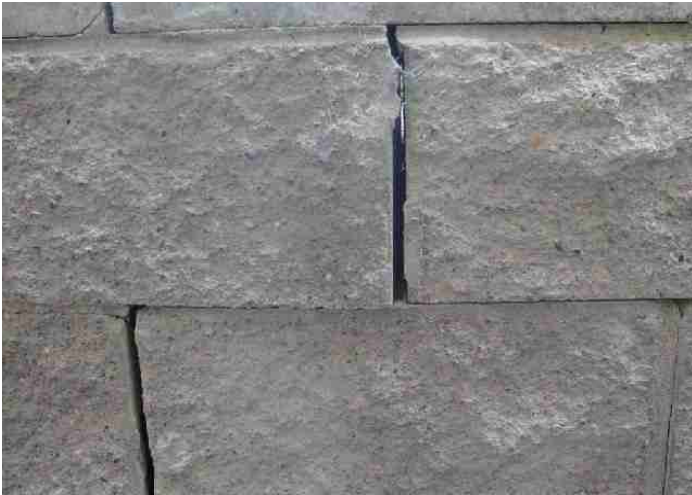
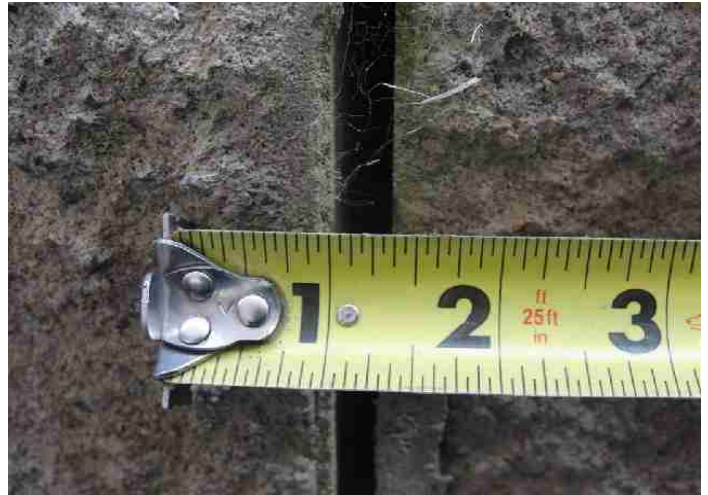
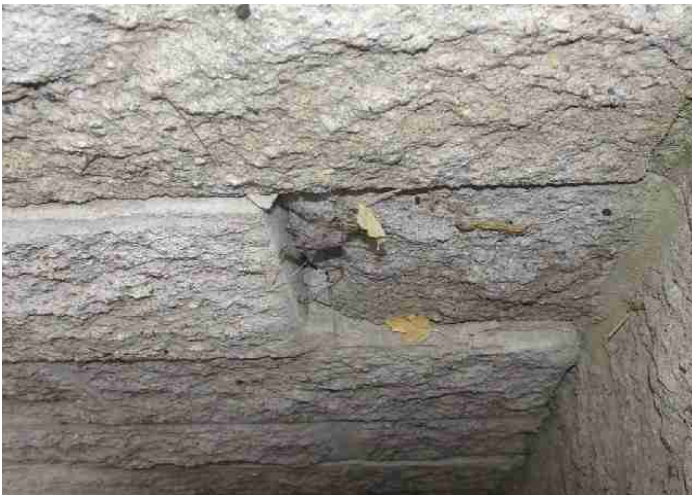
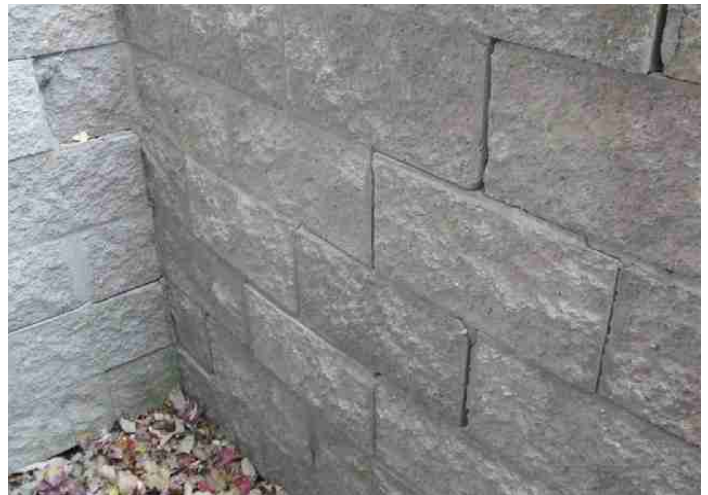
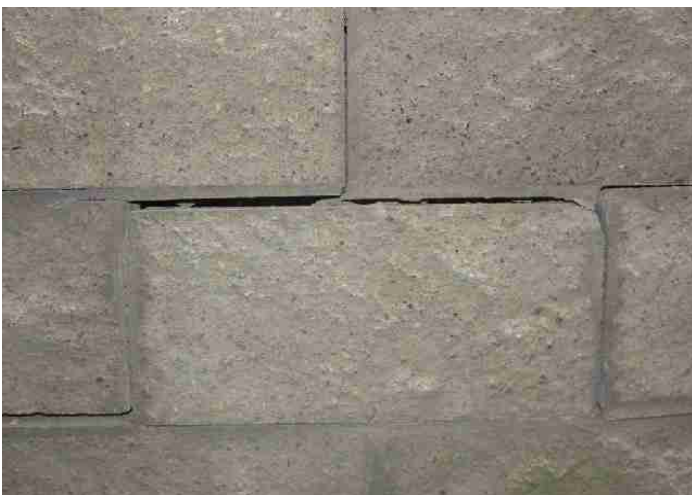
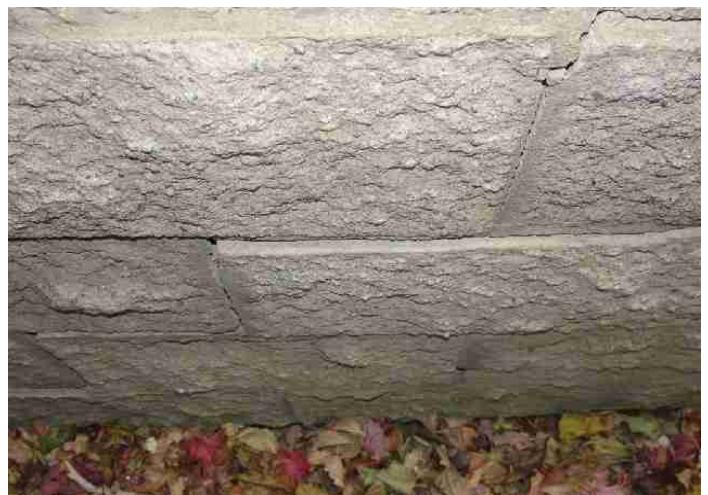
The window well at the north side of the house was collapsing, most likely because of the poor water management at this corner of the house. Have the window well completely re-built, or get a second opinion from a structural engineer. There were cracks in the south window well, but the cracking was much less severe. If you have an engineer inspect the north window well, it would be worth having the south window well inspected at the same time. All of the photos below are of the north window well.

Window well collapsing - *Continued*

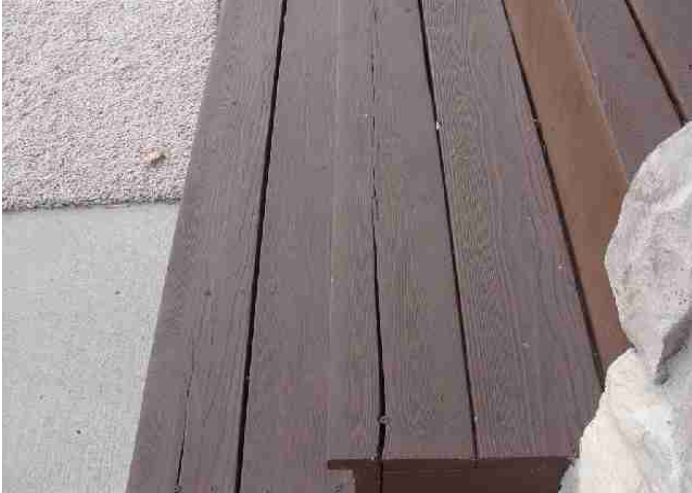
The second step up to the house at the front porch had a large split in the deck board, and could break away. This is a fall hazard. Replace this cracked board.

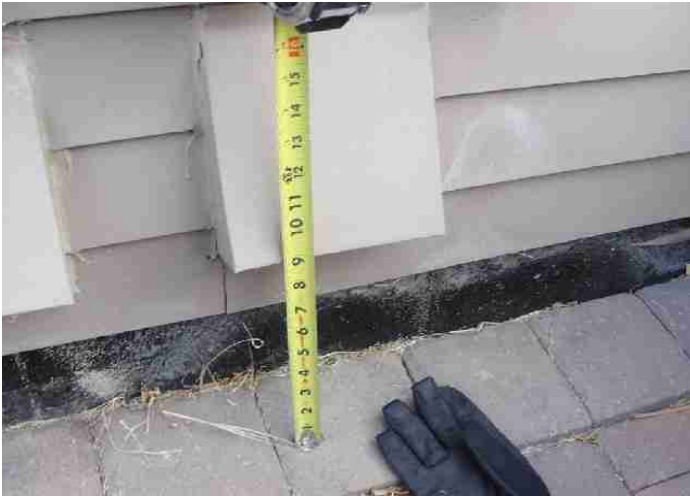
The combustion air intake and HRV intake are too close to the ground. These intakes are required to be located at least a foot above the ground, or above the average snow line. Make sure these vents don't get blocked with debris or snow.

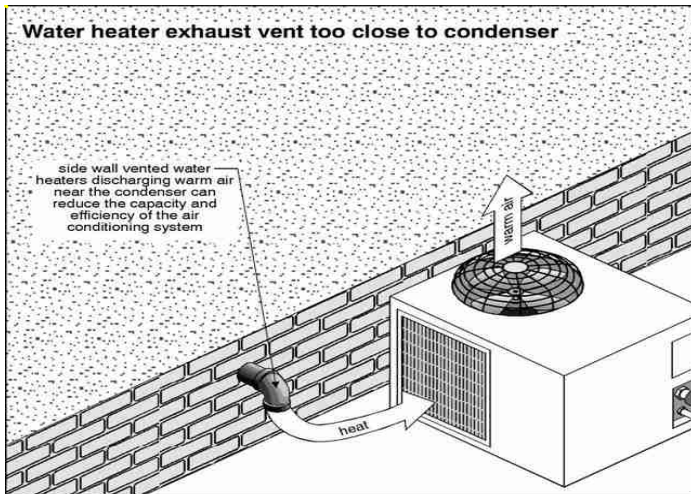
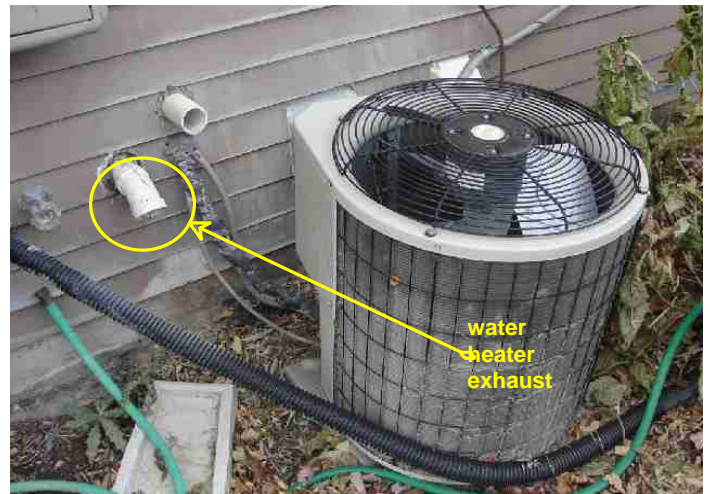
The water heater exhaust is very close to the air conditioner, which will reduce the efficiency of the cooling system. When the water heater is replaced, you should try to have the exhaust re-located.

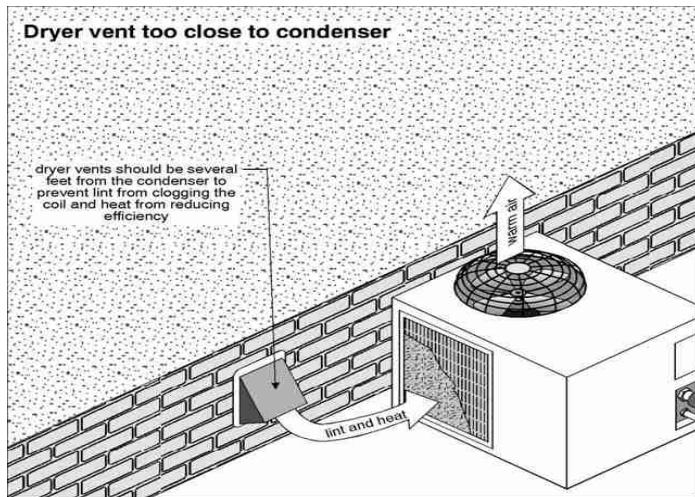
The dryer exhaust is close to the air conditioner. When the dryer exhaust is too close to the air conditioner, excess lint can accumulate on the air conditioner coils, and this will reduce the efficiency of the air conditioner. Monitor frequently in the summer and keep clean by spraying down with a garden hose.

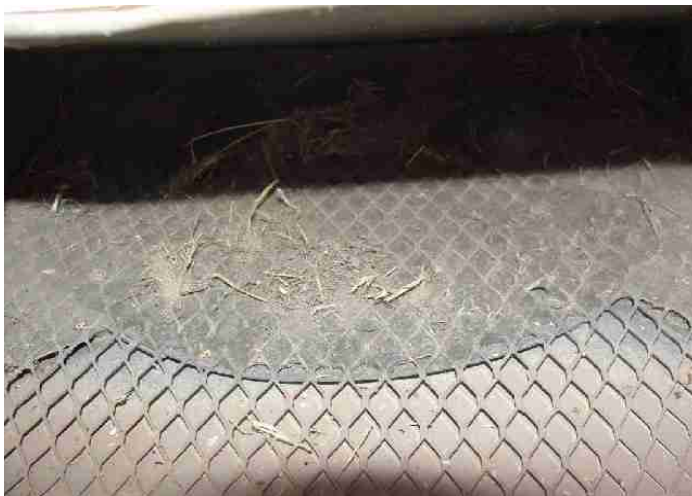
The HRV intake was dirty, and should be cleaned to allow for proper air flow and operation of the HRV.

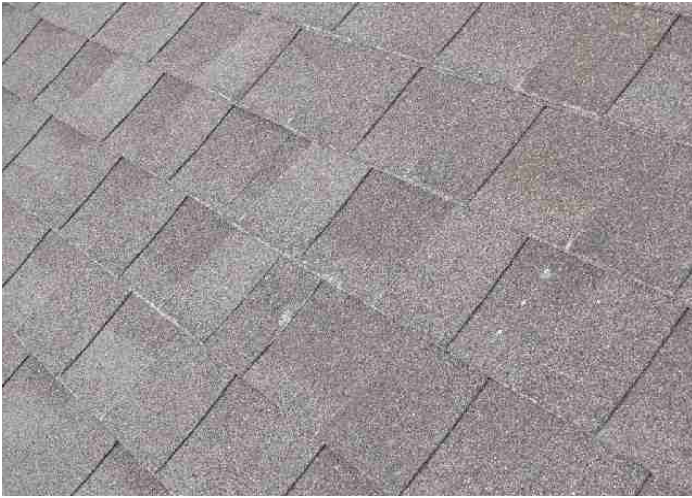
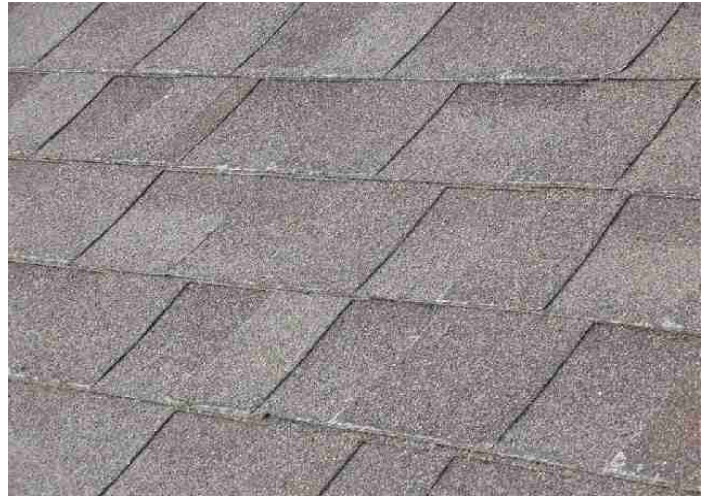
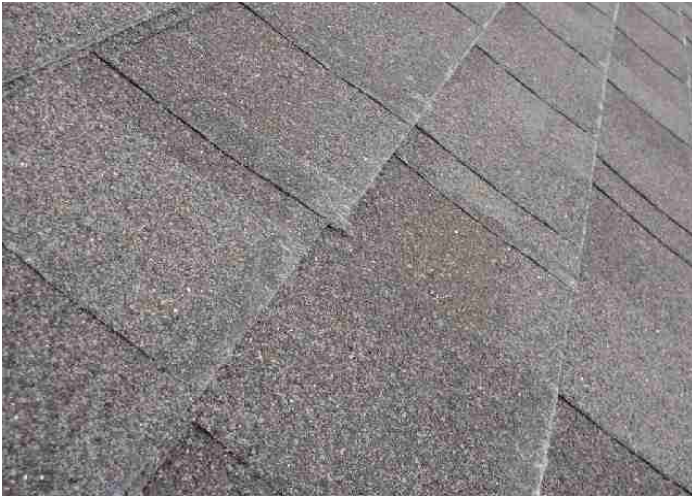
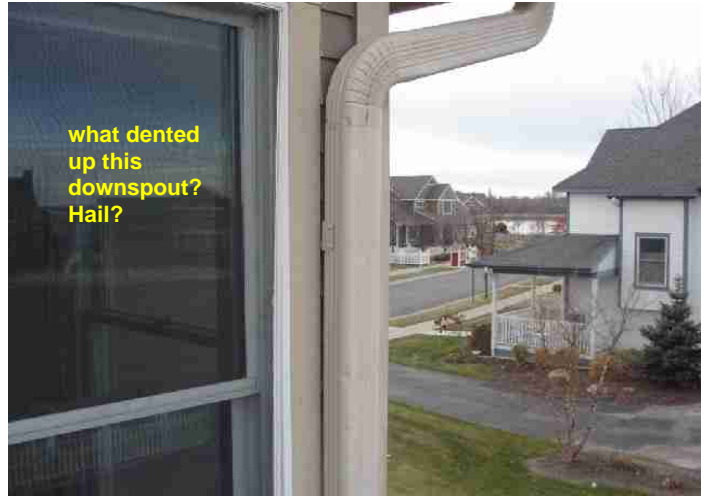
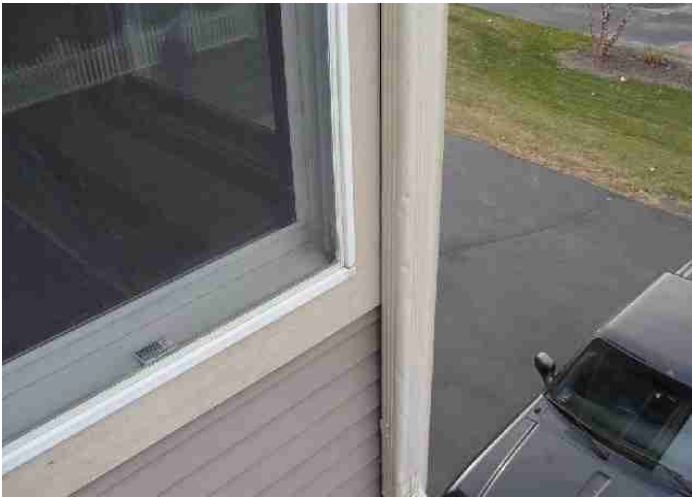
The wear pattern on the composition shingles appears to be attributable to defective materials. Many shingles, especially at the front of the house, had missing granules and damaged mats, to the point where there were exposed fiberglass threads. There is no immediate concern of roof leakage, but this pre-mature wearing will unquestionably shorten the life of the roof. Has there been hail damage at the house? Have there been any claims made for hail damage?

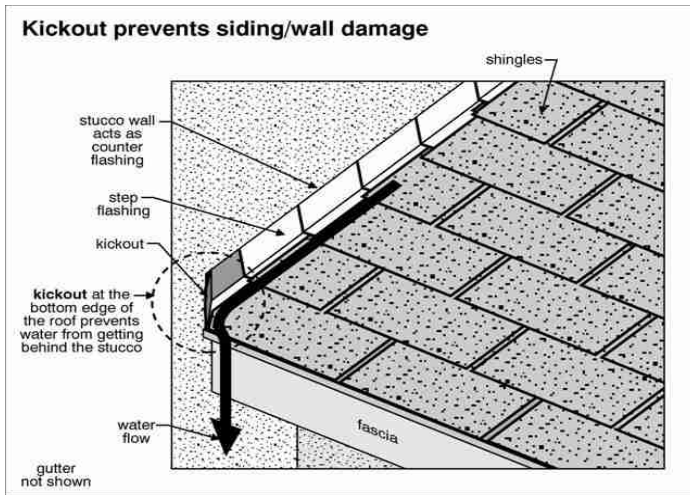
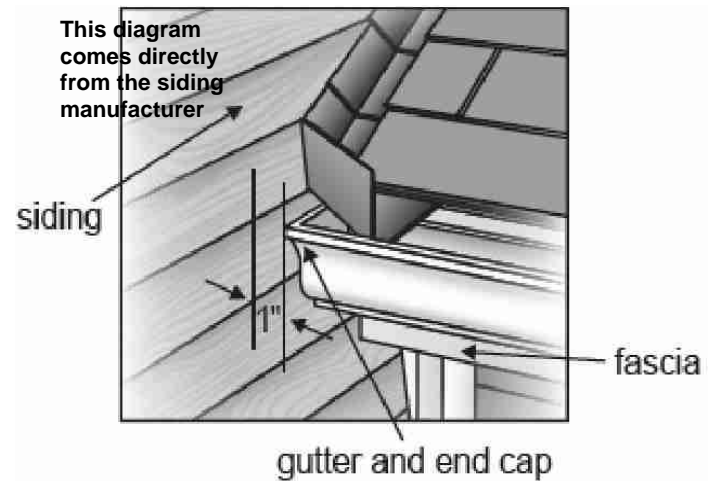
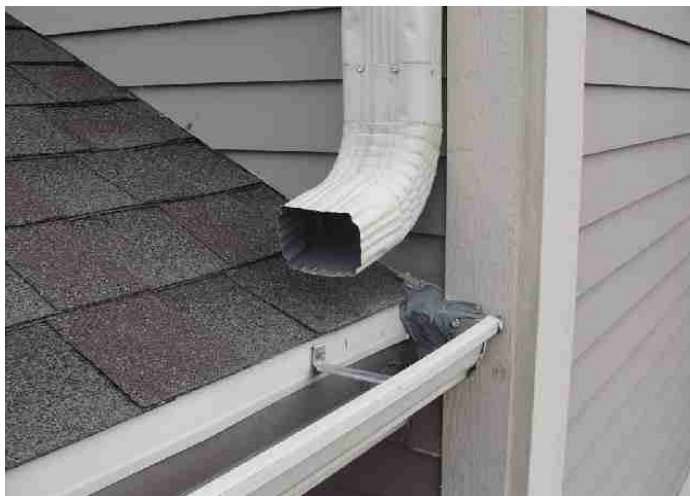
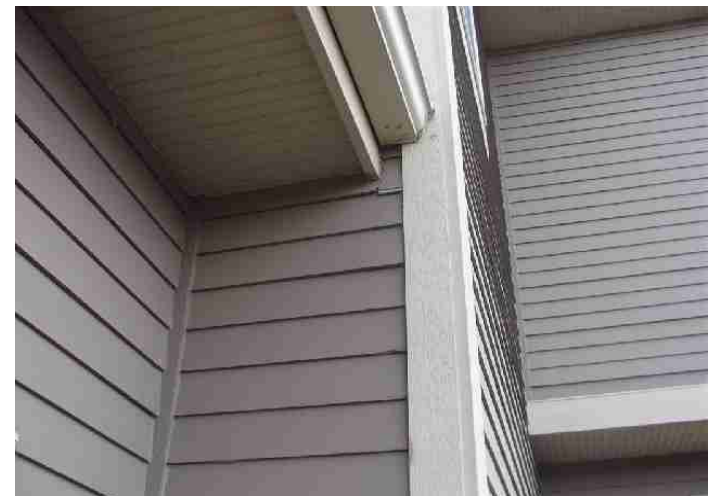
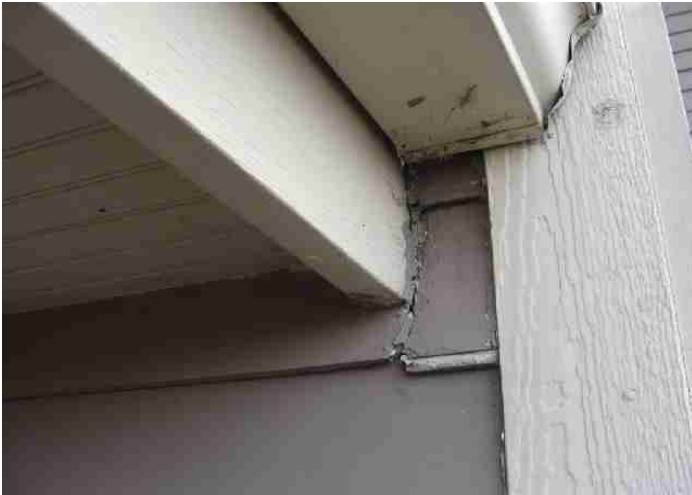
There is no kickout flashing installed at the roof/wall intersection at the south side of the house. Kickout flashing helps prevent potential water intrusion into the wall, it's required by the building code, and it's required by the siding manufacturer. The gutter at this location was also installed too close to the wall - there needs to be a 1" gap between the gutter end and the siding. There has obviously been a water problem at this location, as indicated by the severely deteriorated siding below the gutter, and the heavy caulking / mastic that has been applied here. Have proper kickout flashing installed at this location, have the gutter installed the proper distance away from the wall, have the deteriorated siding removed, have the wall sheathing inspected for water damage, and have it repaired as necessary.

There is no kickout flashing installed - *Continued*

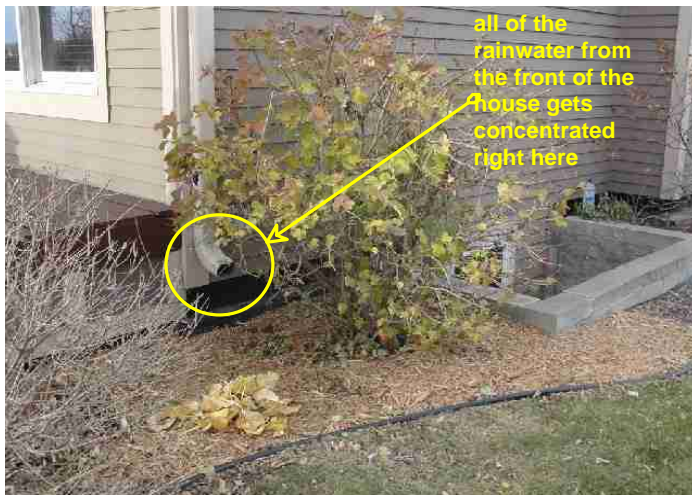
The downspouts lack proper extensions to carry the water away from the foundation. Having a downspout dumping water right up against the house will concentrate the water to one location, and greatly increase the potential for basement water problems, foundation problems, and window well problems. Add downspout extensions to carry the water several feet away from the house.

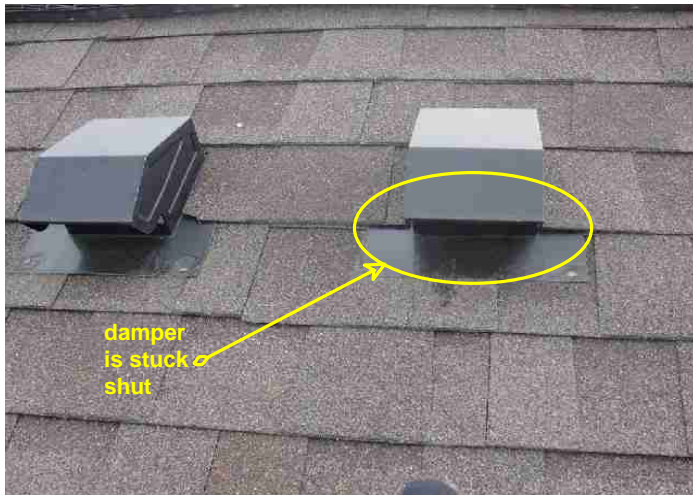
The backdraft damper at the east roof cap for one of the bath fan exhausts was stuck shut. The damper has become stuck to the sealant strip below the damper, which prevents the damper from opening, and forces warm moist air to exhaust in to the attic. Replace the sealant strip with a new one that is made from polyester, which you can obtain from Broan by calling 1-800-558-1711. Order part #S97017696.

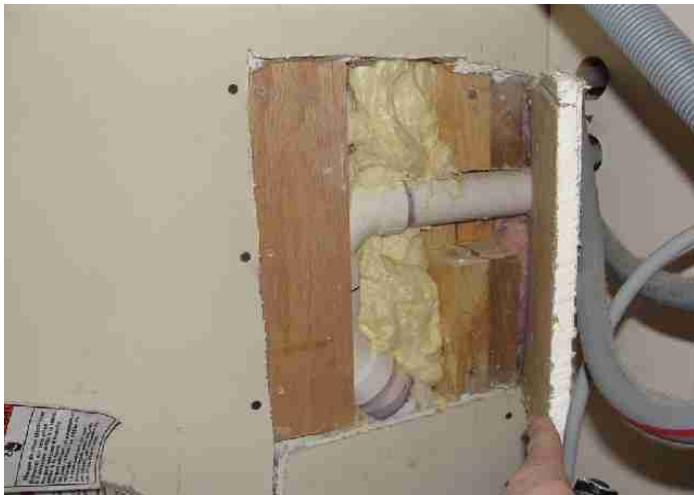
There is a standpipe installed for the washing machine to drain to, but there is no water seal trap provided for the standpipe. This will allow hazardous sewer gas in to the home. Have this repaired.

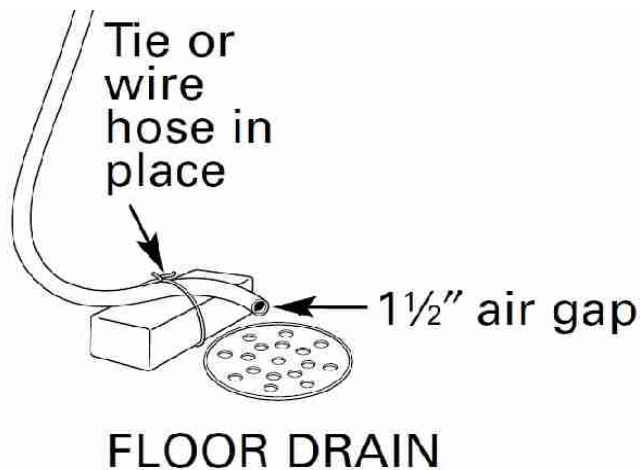
There is no air gap at the drain line for the water softener. I recommend making a 1" air gap for the water softener drain line to prevent any potential cross connection between the potable drinking water and any sewer water that might back up out of the floor drain. To read more about this topic, click here <http://www.structuretech1.com/2011/07/water-softener-installation-defects/>.

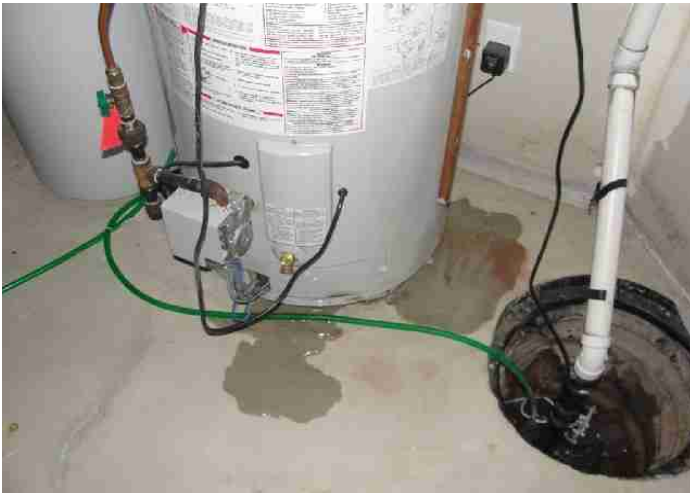
The temperature and pressure relief valve was leaking. This could be happening because there is a pressure reducing valve on the water supply piping coming in to the house, but the piping was concealed by an installed cabinet, so I couldn't verify that this was the case. If there is a pressure reducing valve present, it will prevent the household water from expanding in to the city water supply when it heats up. Without anywhere for the water to go when it gets warm and expands, the pressure relief valve leaks. Try replacing the pressure relief valve. If it leaks again, you should have an expansion tank added to the plumbing system.

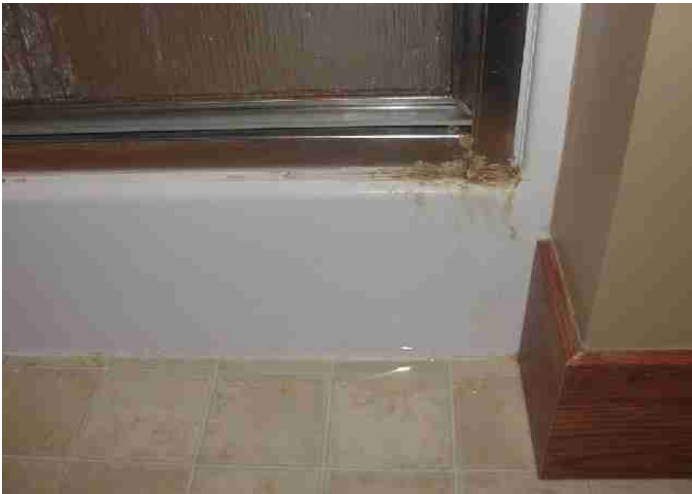
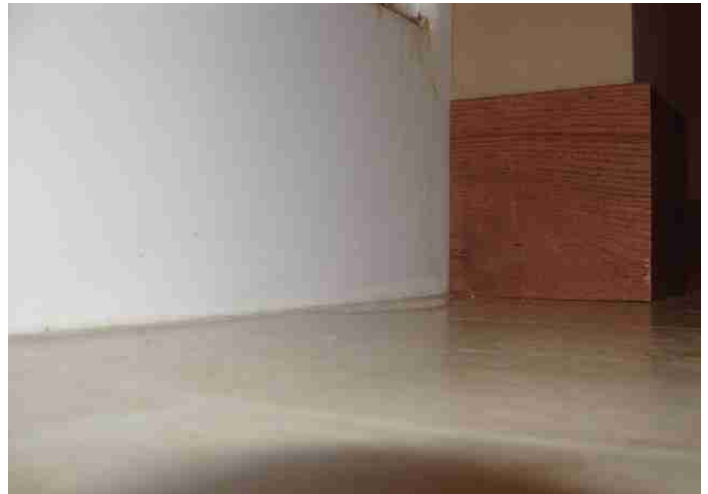
The shower door in the master bathroom leaks when water is directed to the door / wall intersection. Have this leak repaired.

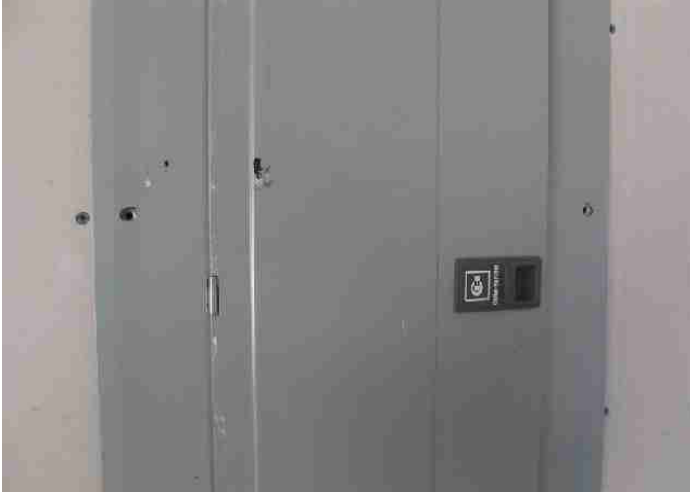
There were two missing screws at the panel cover, which should be replaced to keep the panel cover secure; a loose panel cover might not contain a fire that could start inside the panel. Be sure to use blunt-tip screws, not pointed screws; pointed screws could pierce one of the wires inside the box.

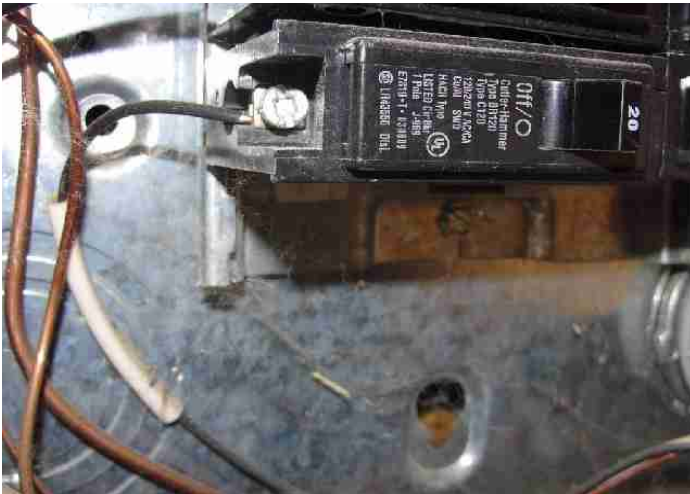
There is one 20 amp breaker that has 14 gage wiring, located at the bottom left opening in the panel. This size wire is only rated for 15 amps - this is a fire hazard. Have this corrected.

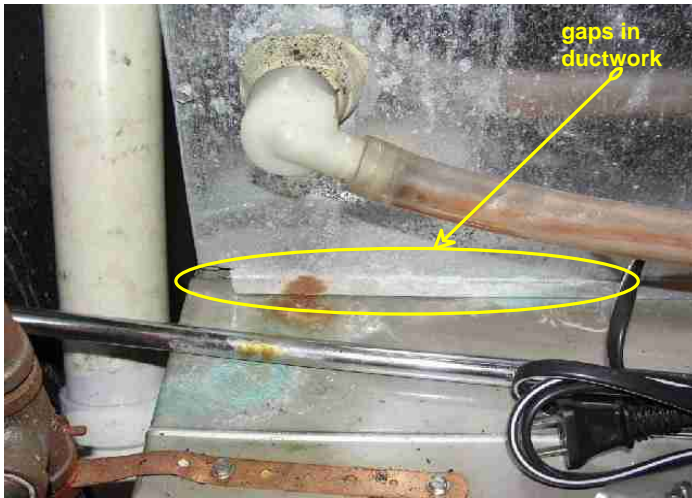
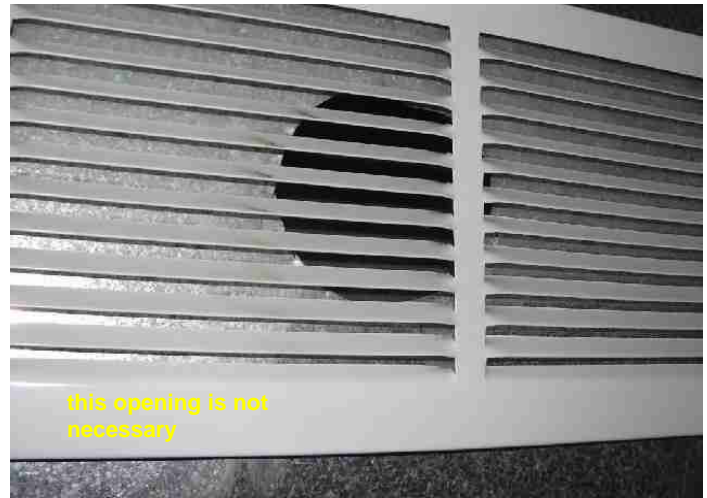
There are various gaps in the metal ductwork for the furnace that should be sealed with metal tape to help prevent unwanted air leakage in to the basement. Sealing these air leaks will help get more air where it's supposed to go. There was also an opening on the side of the furnace which will heat the furnace room; you might want to just have this opening completely blocked off, as it isn't necessary.

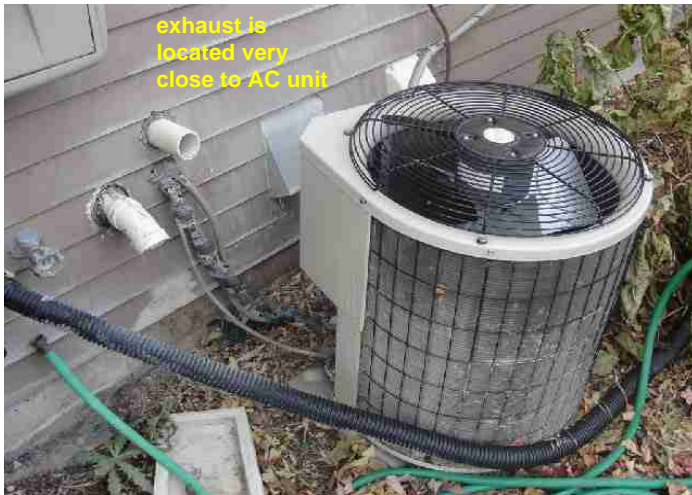
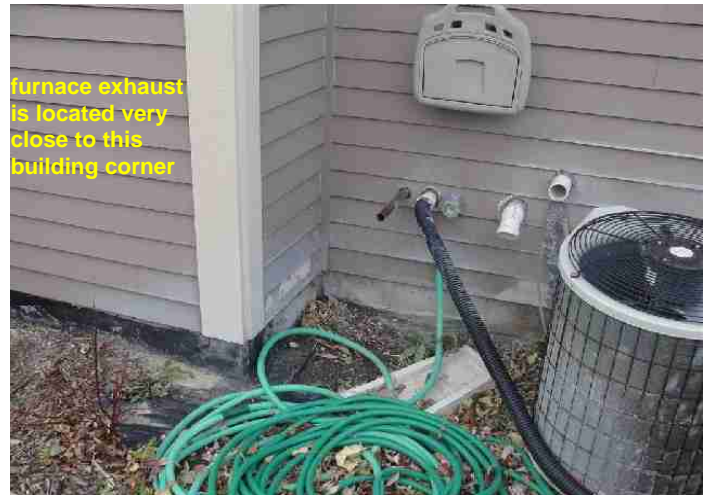
The furnace venting was improperly installed. The installation instructions say "Termination kit should be positioned where vent vapors will not damage plants/shrubs or air conditioning equipment". The vent terminal couldn't possibly be located much closer to the air conditioning equipment. The installation instructions also say "Termination kit should be positioned so that it will not be affected by wind eddy (such as inside building corners) or allow recirculation of flue gases, airborne leaves, or light snow." The vent terminal is located in just a corner. The intake and exhaust were also located on opposite sides of the house, which is blatantly wrong; the installation instructions say to install the intake and exhaust terminals exactly as shown in the diagram below, left. This improper installation could cause the furnace to malfunction. Have the installation corrected.

Improper furnace venting - *Continued*

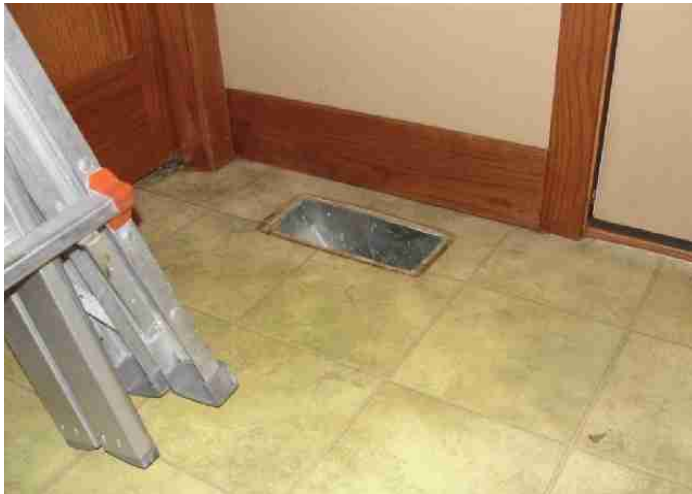
There was a missing register cover in the laundry room.

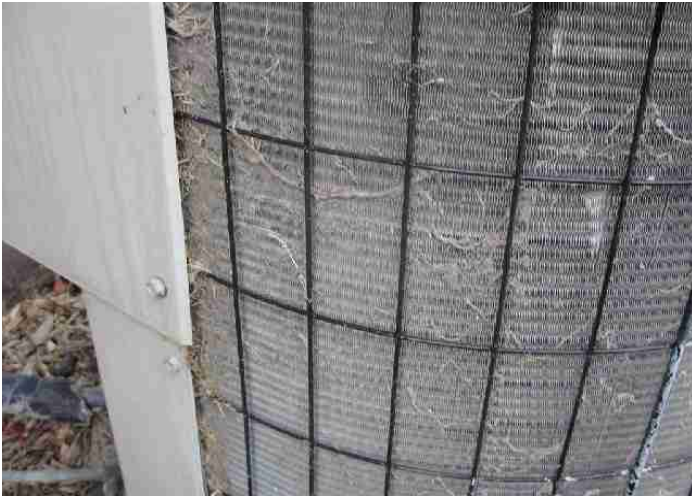
The condensing coil is dirty, which will reduce the efficiency of the unit. Clean the condensing coil.

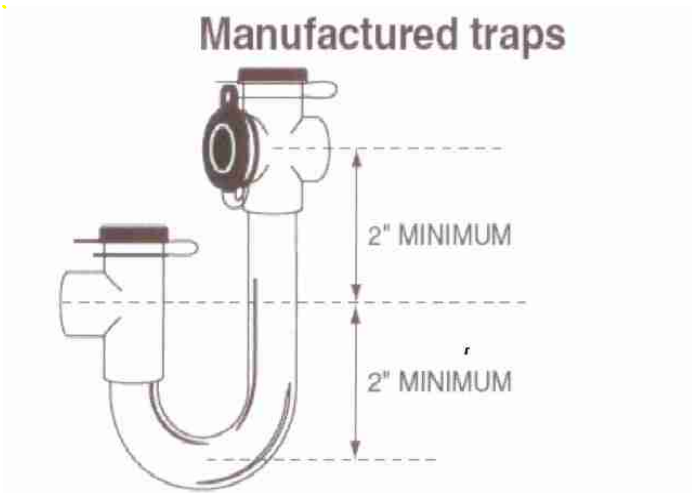
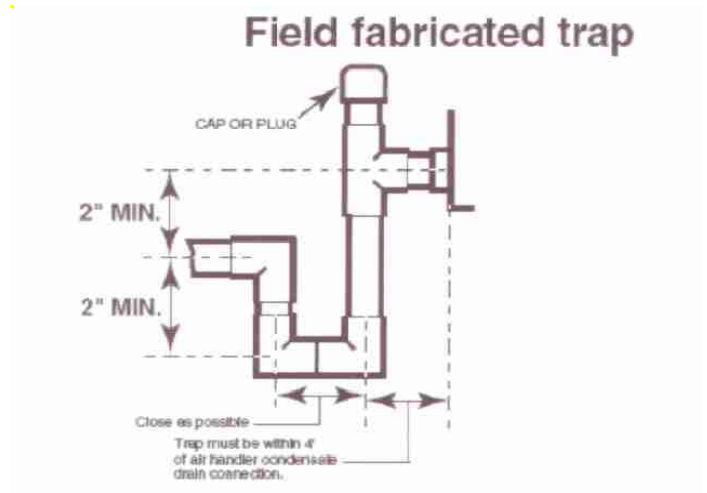
There is no trap installed at the condensate drain pipe. The primary purpose of a trap is to prevent air leakage - think of a missing trap as having a small hole in the side of the ductwork. To prevent this air leakage, you could install a trap on the condensate drain. To read more about this, click here <http://www.structuretech1.com/blog/2011/06/ac-condensate-trap/>

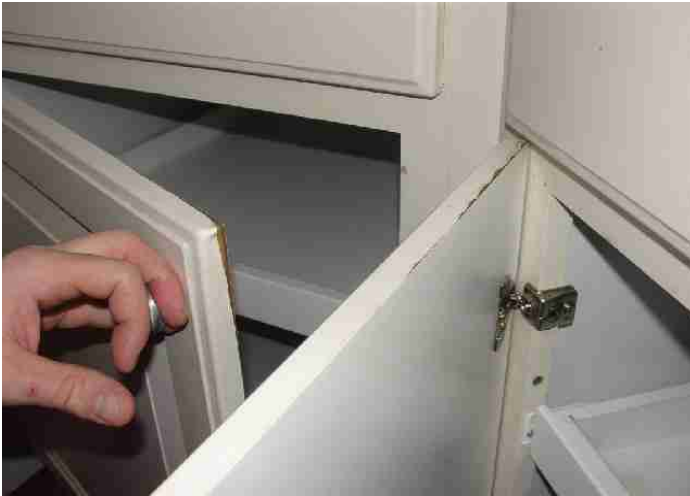
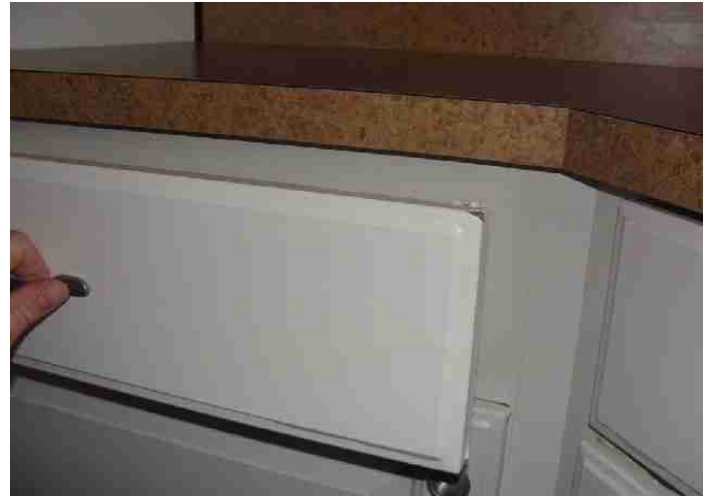
The finish was starting to come loose or warp at a few of the kitchen cabinets and drawers.

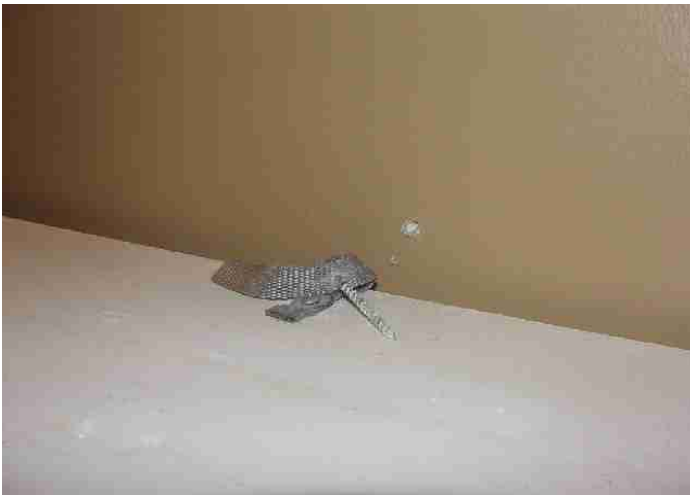
The cabinet above the toilet in the basement bathroom needs to be secured to the wall to help prevent it from tipping over. There was a screw present, but it was just drilled in to the drywall, which is useless. It needs to be drilled in to a wall stud.
