# Structure Tech Home Inspections

## SUMMARY REPORT

**Client:** New Home Buyer  
**Inspection Address:** 123 Perfection Street, Minneapolis, MN  
**Inspection Date:** 11/2/2011 Start: 8:30 am

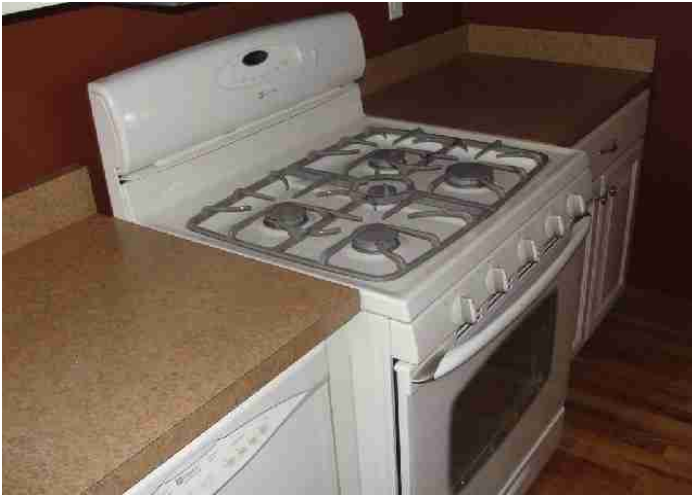
The kitchen range protrudes from the wall because there is a big coil of gas tubing behind the range. This is a nuisance, and prevents an anti-tip bracket from being properly installed. Have this repaired.

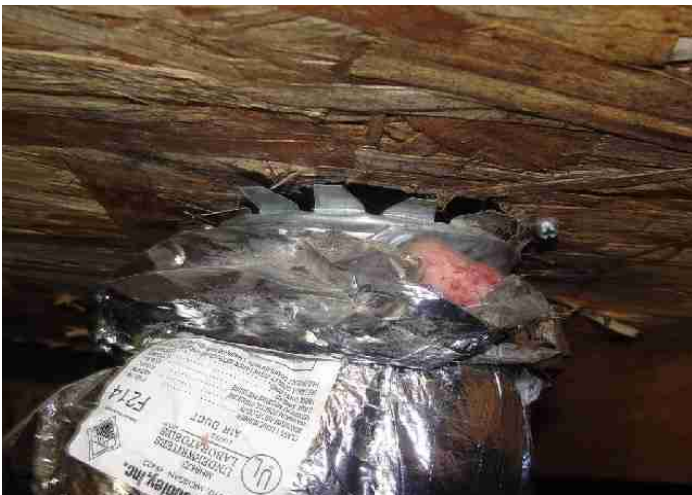
The connection for one of the bathroom exhaust fans at the west roof cap was loose in the attic, which will allow warm, moist air to escape in to the attic. Have the connection repaired so it's airtight.

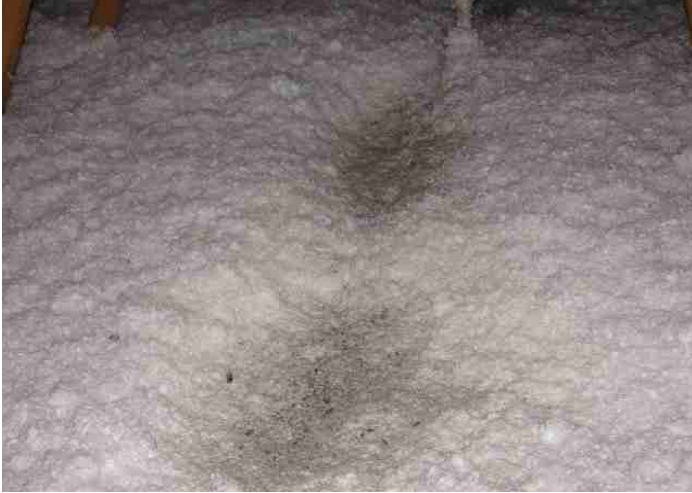
There were several sections of insulation that were matted down, and they were all located directly below the ridge vents. This has probably happened because light, fluffy snow drifted in underneath the ridge vents and settled on the attic floor. If you wanted to prevent this from happening, you could try installing a different style of ridge vent, or change the ridge vents to standard roof roofs. There is no guarantee that doing either one of these things would prevent this from happening though.
