REDUCING THE FIRE HAZARD

IN ALUMINUM-WIRED HOMES

Jesse Aronstein, PH.D., P.E.

Latest update: July 6, 2007

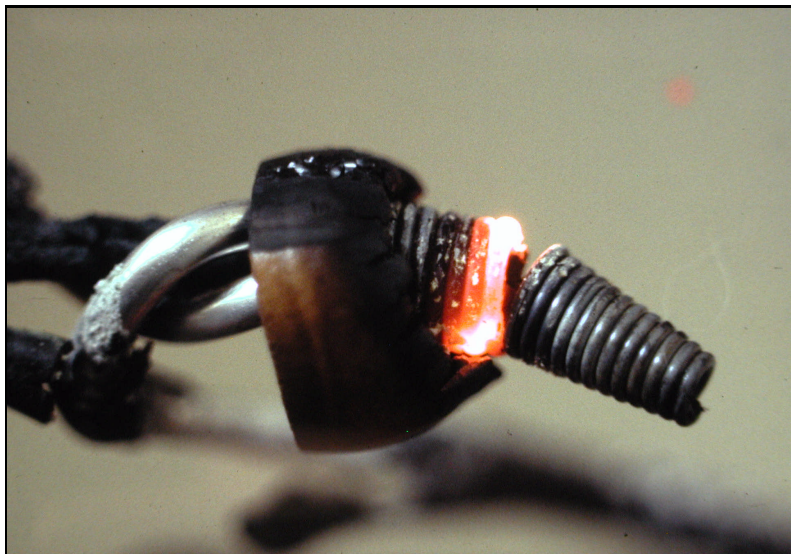
FIGURE 1 - ALUMINUM WIRE SPLICES MADE WITH TWIST-ON CONNECTORS CAN BE DANGEROUS. The use of most types of twist-on connectors with aluminum wire can lead to hazardous results. This twist-on pigtail connection (two #10 aluminum wires with one #12 copper wire, in a 20-amp circuit), made with a twist-on connector that was UL listed for use with aluminum wire at the time, remains electrically functional in the circuit, but it becomes extremely hot whenever a significant amount of current flows. The heat has deteriorated the insulation on both the connector and the wires. In this photo, a portion of the connector's spring is red hot, at current well below the circuit rating.

The most certain corrective action for all cases would be to rewire the home with copper wire. This is expensive and impractical in most cases. A practical approximation to rewiring can be achieved by a method known as "pigtailling", using a specially-selected connector and installation method to splice a short length of solid copper wire to each aluminum wire end. The copper wire "pigtail" is then connected to the circuit breaker, light fixture, receptacle, dishwasher, or other termination. This method is only effective if the connections between the aluminum wires and the copper pigtails are extremely reliable. Pigtailling with some types of connectors, even though they might be presently listed by UL or certified by CSA for the application, can lead to increasing the hazard.[5][6] (See Figure 1.)

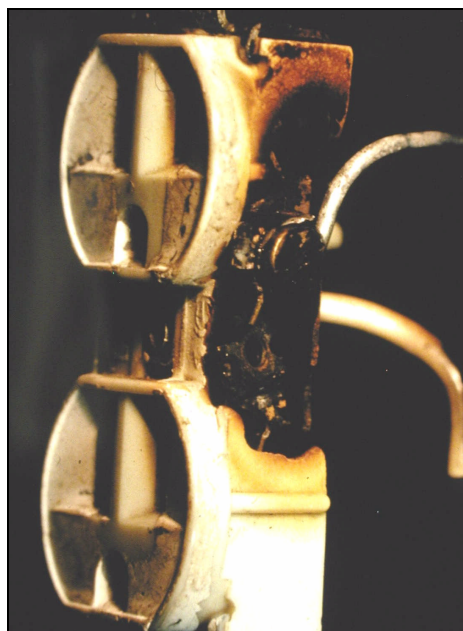
FIGURE 2 - EXAMPLE OF OVERHEATING OF ALUMINUM-WIRED TERMINALS ON A RECEPTACLE. Enough heat was generated by current flowing through the aluminum wire connections to cause charring of the receptacle body and disintegration of the insulation that was on the wire. Note that the face of the receptacle, as the homeowner or an inspector would have seen it, with the cover plate on, would look normal.

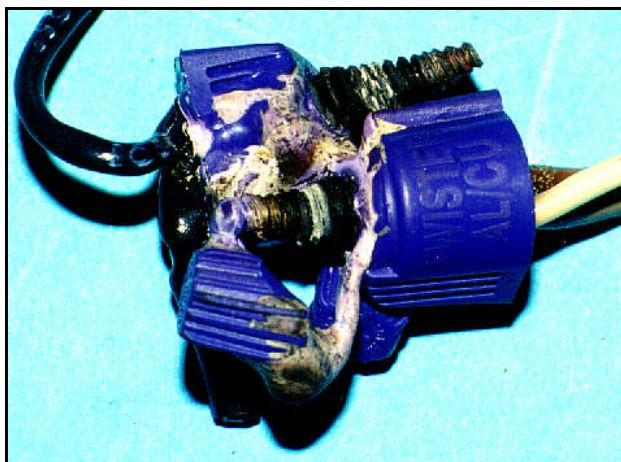
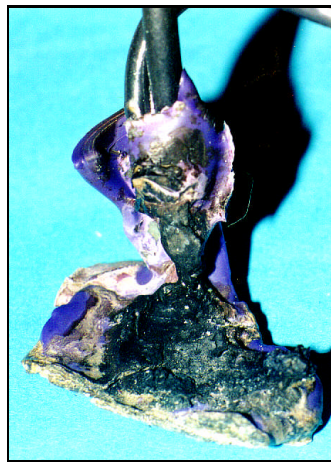
**FIGURE 5 - FIELD FAILURES OF ALUMINUM TO COPPER
SPLICES MADE WITH IDEAL #65 CONNECTORS [12]**

A. THESE TWO FAILED SPLICES ARE ADHERED

PLASTIC SHELLS SHELL MELTED AND CHARRED.
THE CHARRING INDICATES THAT

B. SEVERE FAILURE, PLASTIC

TOGETHER BY THE MELTED
IT HAD PROBABLY IGNITED.

3. IDEAL #65: came on the market in the mid-1990's. Within three years of its introduction, the first report of field failure surfaced. There have been additional failures reported since then.

Additionally, field burnouts have now been reported with the Ideal #65 connectors in their rated applications. With CPSC skeptical (and requesting that UL withdraw its listing), the manufacturer initially agreeing that the connector is not for the pigtailling retrofit application, independent tests clearly demonstrating poor performance, and field failures reported, the use of the Ideal #65 "Twister" connector for the pigtailling application is definitely not recommended. If the COPALUM repair is not available, use the AlumiConn connector (See Section 1C).
