General Summary

Structure Tech Home Inspections

Inspection Address
12345 Any Street
Minneapolis MN

Inspection Report

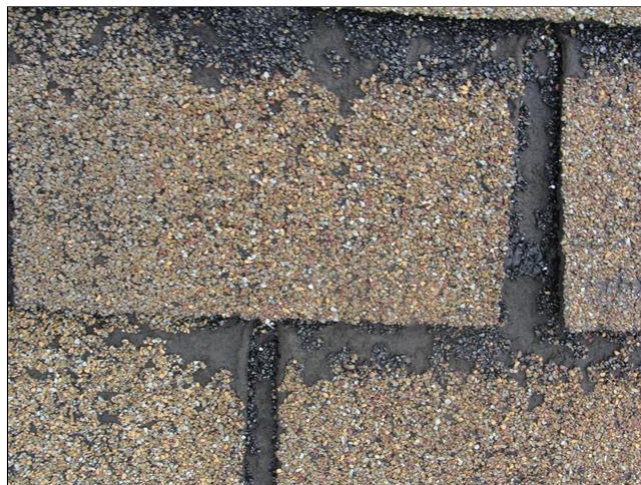
There were small holes in the shingles throughout the roof. These are all potential leak areas, and there were signs of leakage visible from the garage attic space. The shingles at the upper south side were severely deteriorated, which may indicate a defective shingle. Have the roof covering replaced.

Deteriorated shingles

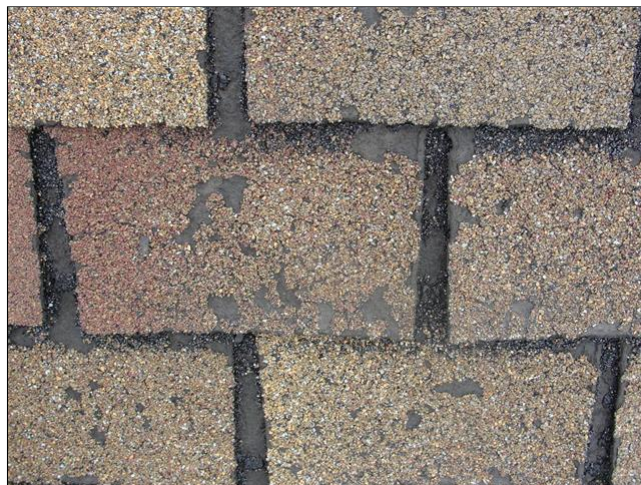
Deteriorated shingles

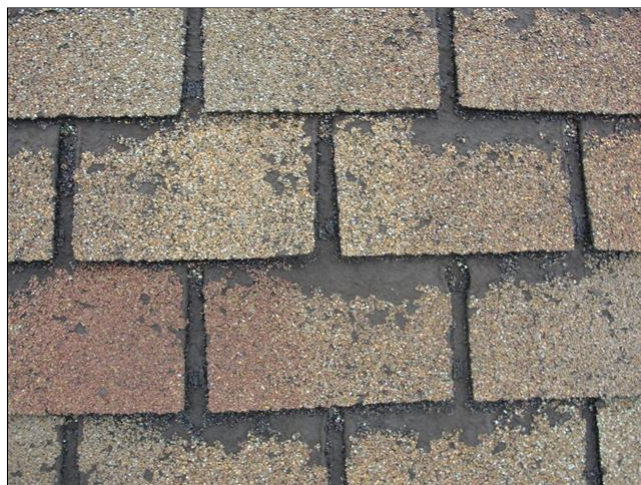
Deteriorated shingles

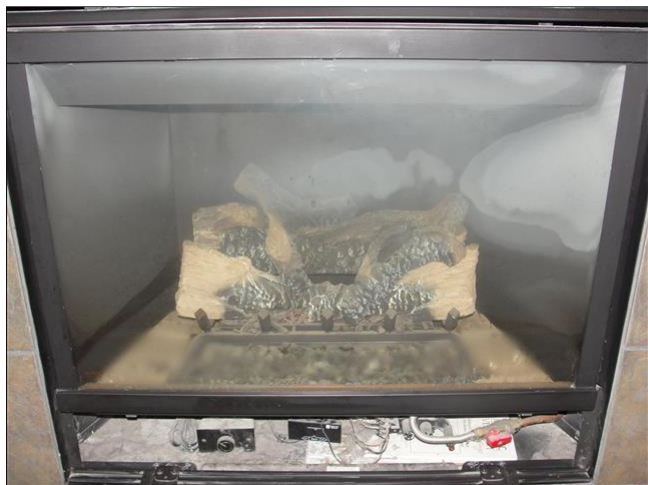
There was a white haze on the glass at the gas fireplace. For information on how to clean the glass, click [here](#).

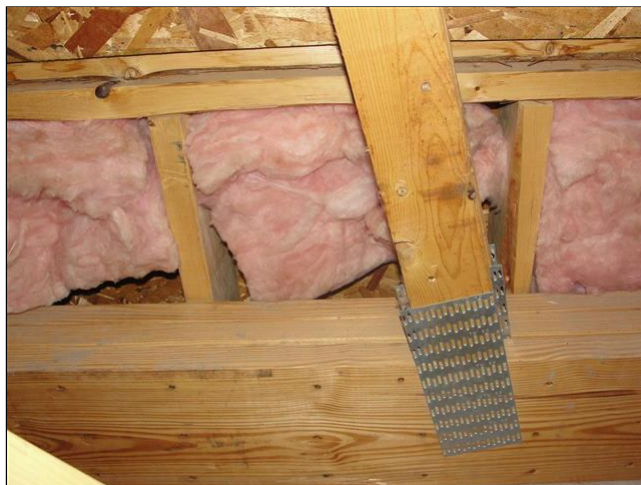
The insulation at the rim space between the first and second floors was incomplete in the garage, and should be re-done to help reduce energy loss at this location.

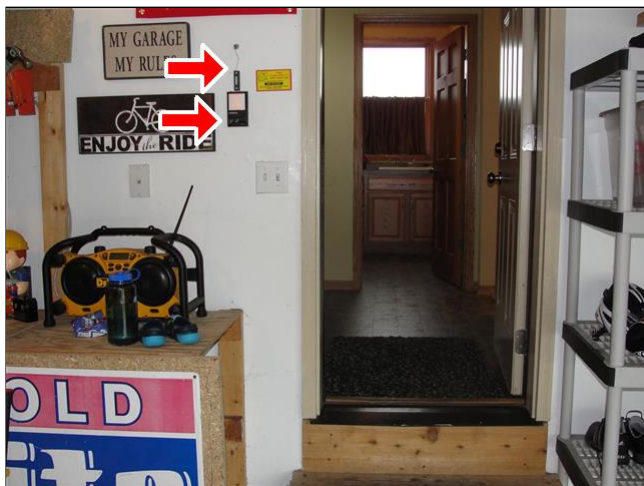
(2) The wall buttons for the garage door openers were less than five feet high (measured from the garage door threshold), which is the minimum height requirement to help prevent small children from operating the opener. Raise the opener buttons for safety.

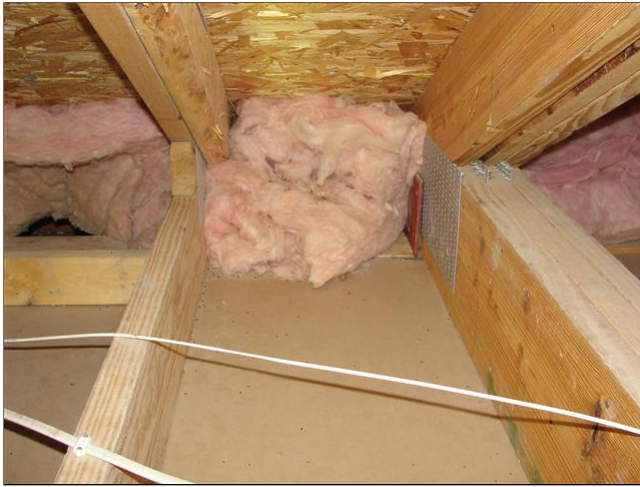
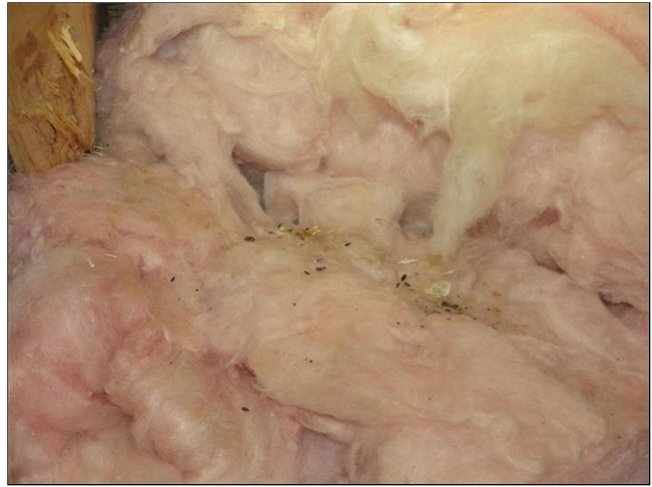
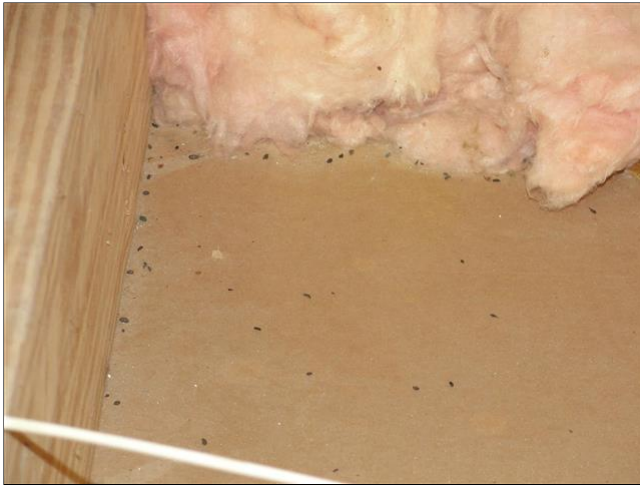
There were mouse droppings in the garage attic.

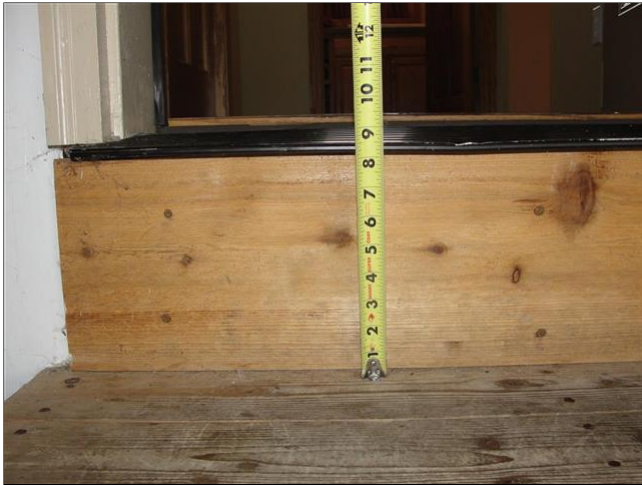
The steps at the garage stairway had uneven riser heights. Steps should have uniform heights to help prevent trip-hazards.
