# Structure Tech Home Inspections

## SUMMARY REPORT

**Client:** New Home Buyer  
**Inspection Address:** 123 Perfection Street, Minneapolis, MN  
**Inspection Date:** 11/2/2011 Start: 8:30 am

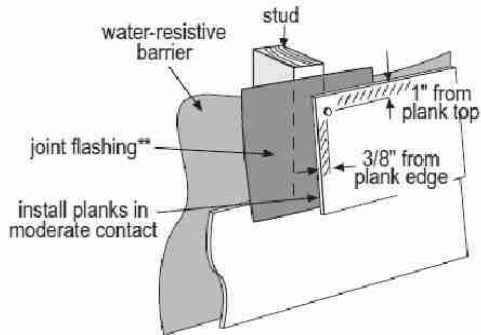
James Hardie does not recommend the use of caulk at field butt joints.

Install factory finished edges together at butt joints.

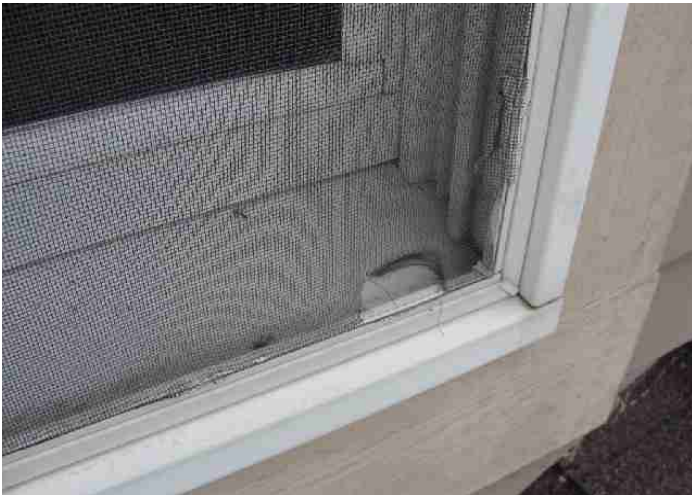
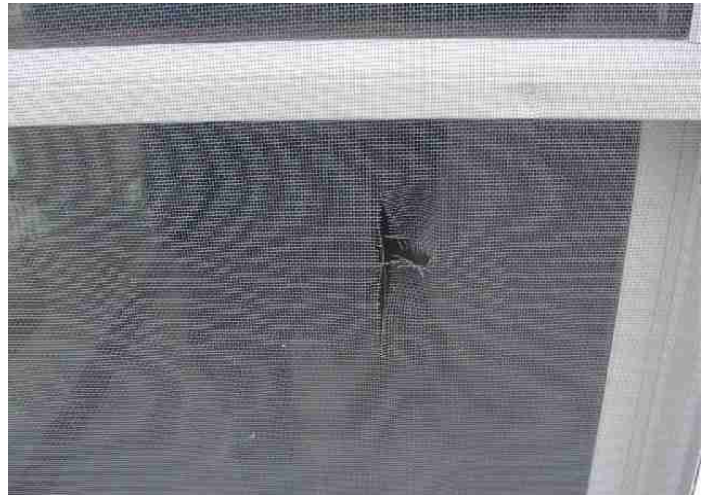
The upper screens at the west side of the house had several holes in them.

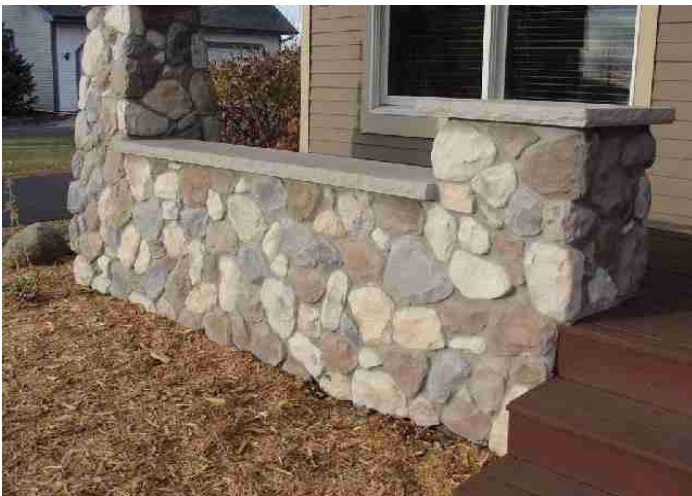
The front porch was low enough to the ground to not require guardrails (less than 30" high), however, the walls at the porch were at a height that a child could easily climb on top of, and the fall from the tops of the walls to the ground was much more than 30". This is a safety concern for small children.

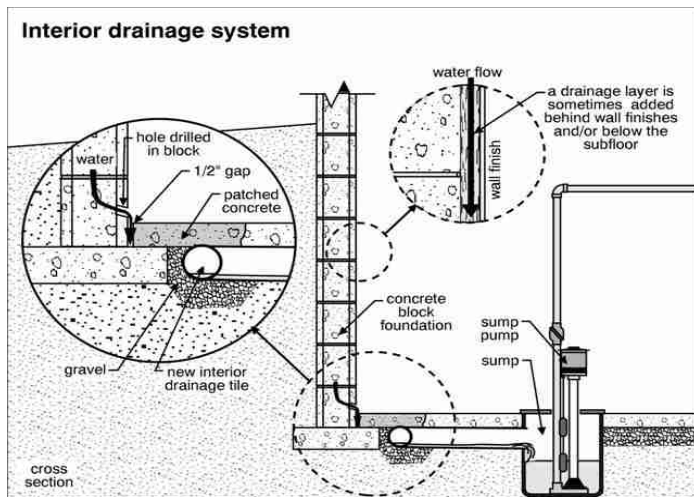
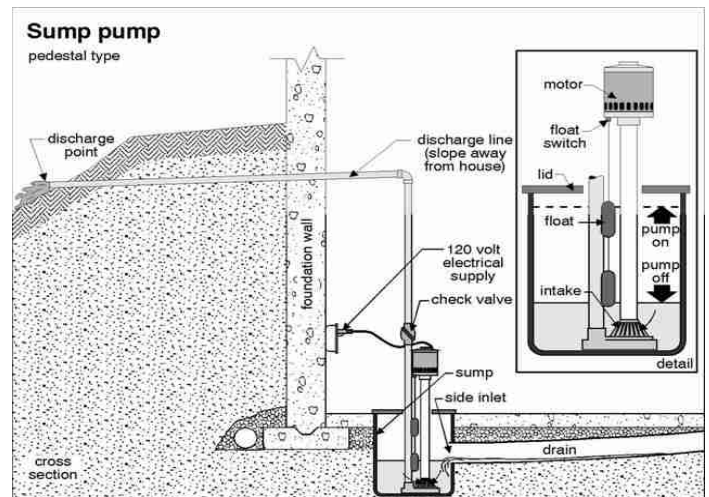
The pump was operational at the time of the inspection.

You should consider having a backup sump pump installed to guard against your basement flooding when the primary pump fails, or during a power outage. You can read more about this topic here - <http://www.structuretech1.com/2011/07/backup-sump-pumps/>.

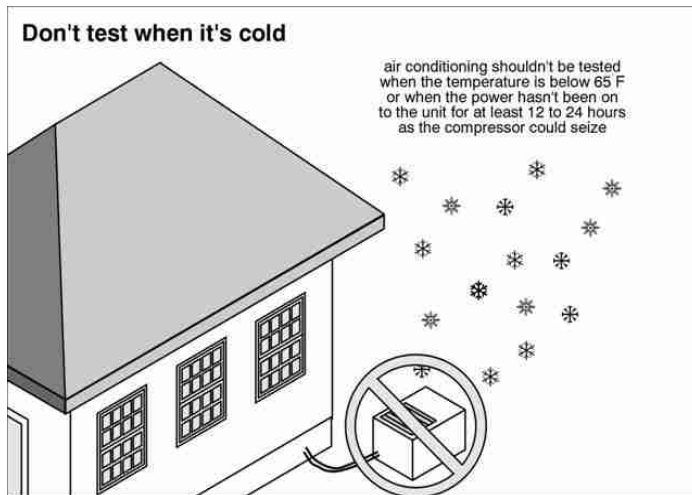
The air-conditioning system could not be tested because it was too cold outside, and to test it would risk damaging it. You should verify with the seller that the system is functional.

The condensing coil is dirty, which will reduce the efficiency of the unit. Clean the condensing coil.
